Re: NEPA Reevaluation Approval for the **FrontRunner Forward Program – North of American Fork Double Track Project**

FrontRunner Forward

The North of American Fork Double Track Project is one of many projects under the FrontRunner Forward Program (also known as the FrontRunner 2X project), which includes double tracking and realigning certain sections of FrontRunner, constructing a maintenance facility, and constructing a new infill station. Further details about investments associated with the FrontRunner Forward Program are included in a separate report, *FrontRunner Forward Strategic Double Track Recommended Service Alternative Overview – A Planning and Environmental Linkage Study (PEL)* (UTA 2025).

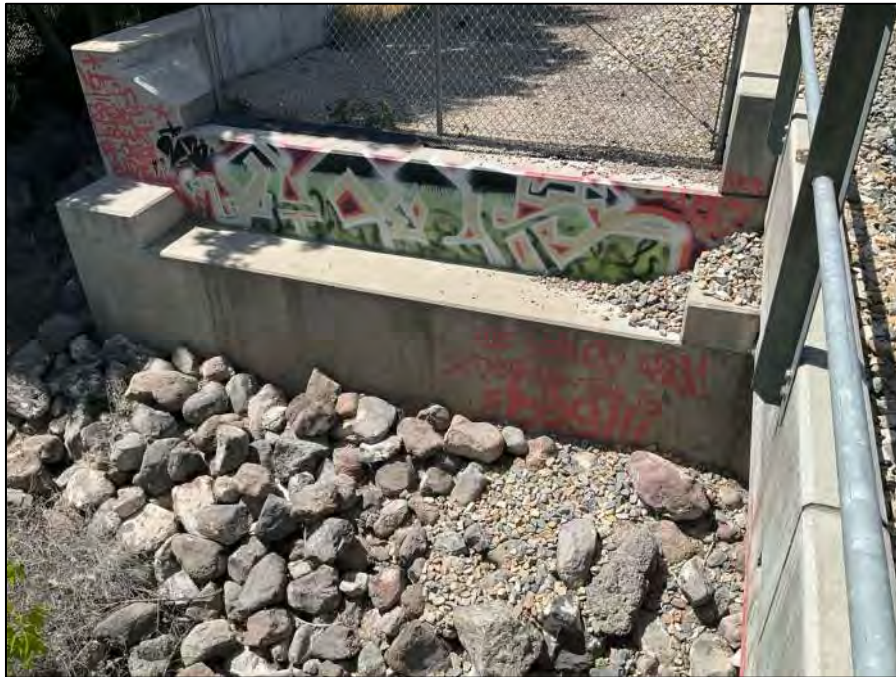
4.	_____	_____	_____	_____

The existing north and south abutments located west of the structure were constructed to accommodate a future rail line (Figure 1). These were inspected in addition to the in-service structure and the following defects were noted:

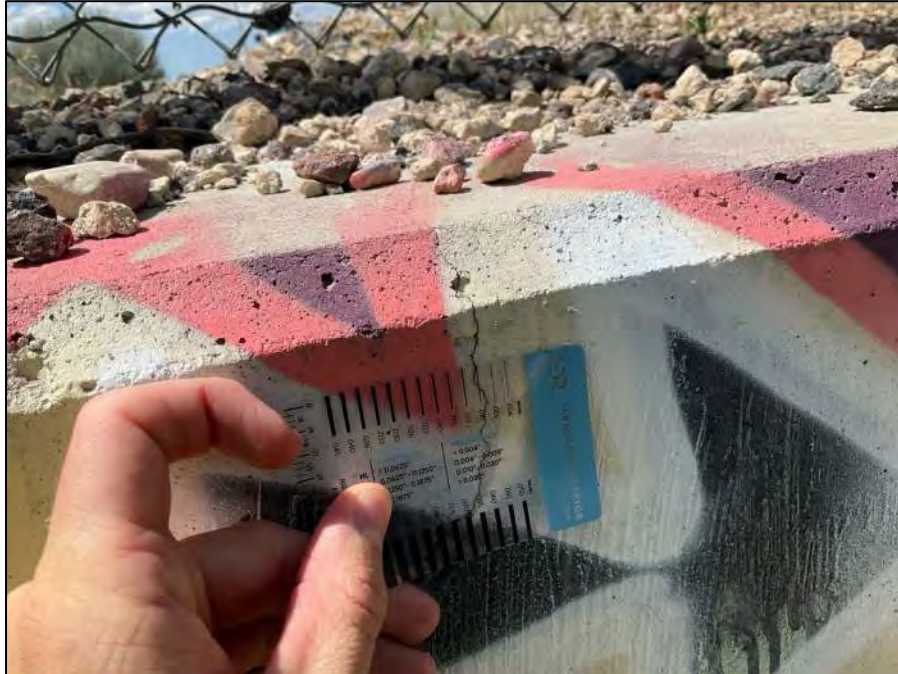
- Vertical cracking up to 0.01" wide (Figure 2)
- 9" Tall x 13" Wide shallow spall in Northwest Wingwall (Figure 3)

Figure 2 – Narrow Vertical Cracking in North Abutment

These defects are considered minor and do not diminish the as-built capacity of the substructure. Work to be performed on this bridge is not anticipated to disturb the American Fork River and potential June Sucker habitat. The minor defect repair work can be accessed without entering the American Fork River and equipment access for superstructure work will be from above the river. See Figures 4 and 5 for potential site access.

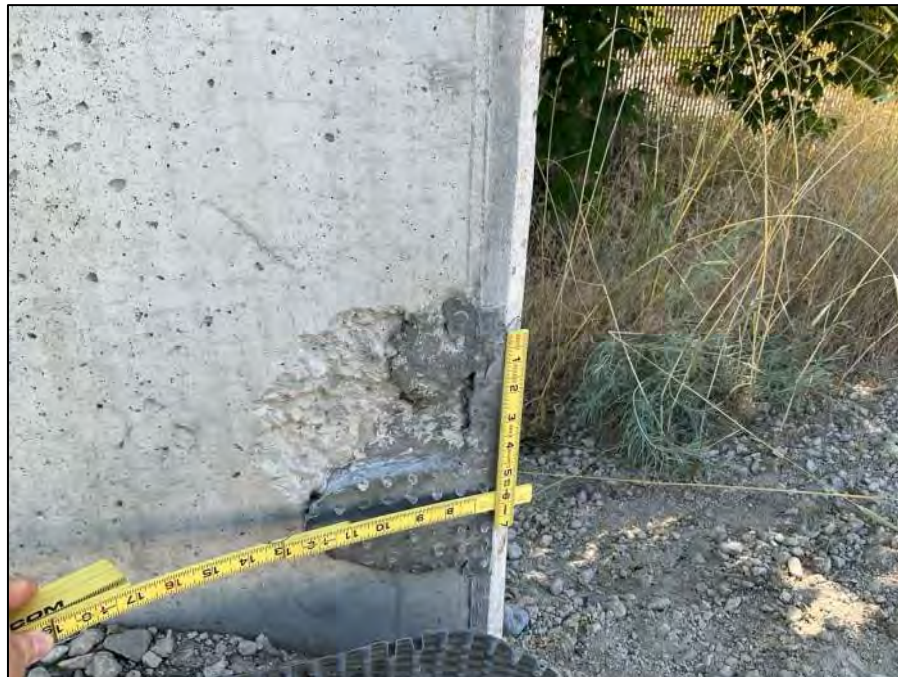
Figure 3 – Shallow Spall in Northwest Wingwall

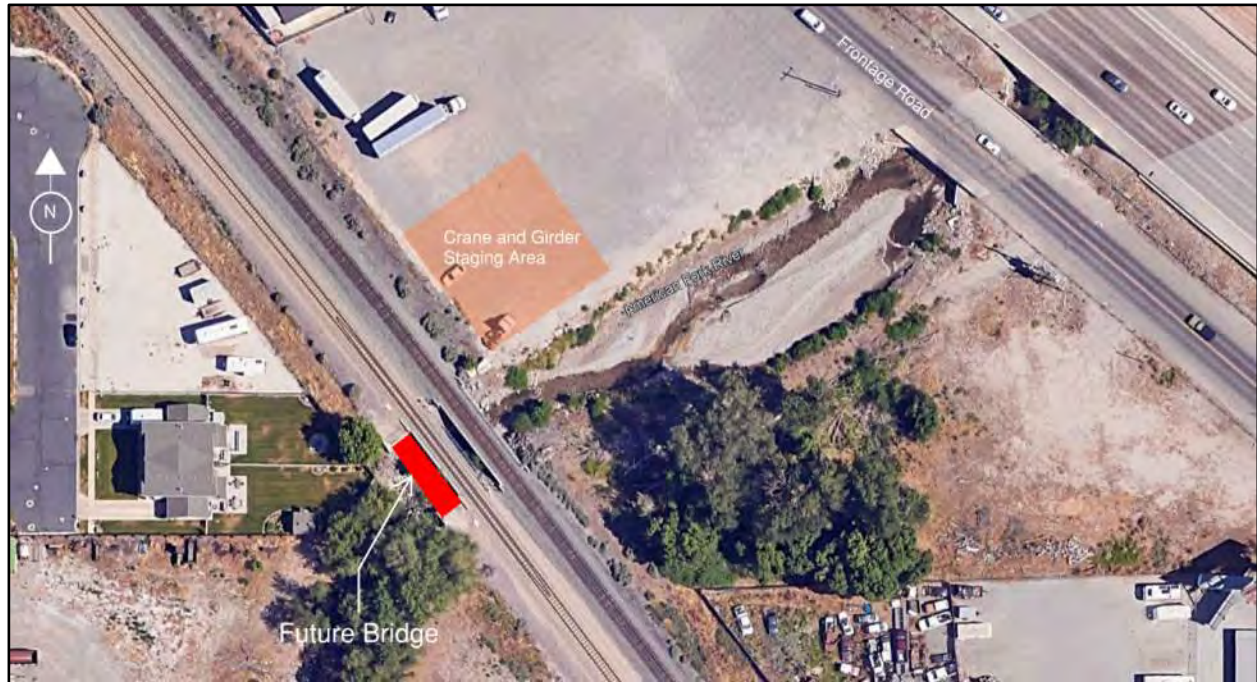
Figure 4 - Potential Crane and Girder Staging Area
