Re: NEPA Approval for the **FrontRunner Forward Program – North of Clearfield Double Track Project**

**Attachment 1:
North of Clearfield Double Track Project
Figures**

**Attachment 2:
North of Clearfield Double Track Project
Plan Set**

**Attachment 5:
North of Clearfield Double Track Project
Noise and Vibration Assessment**

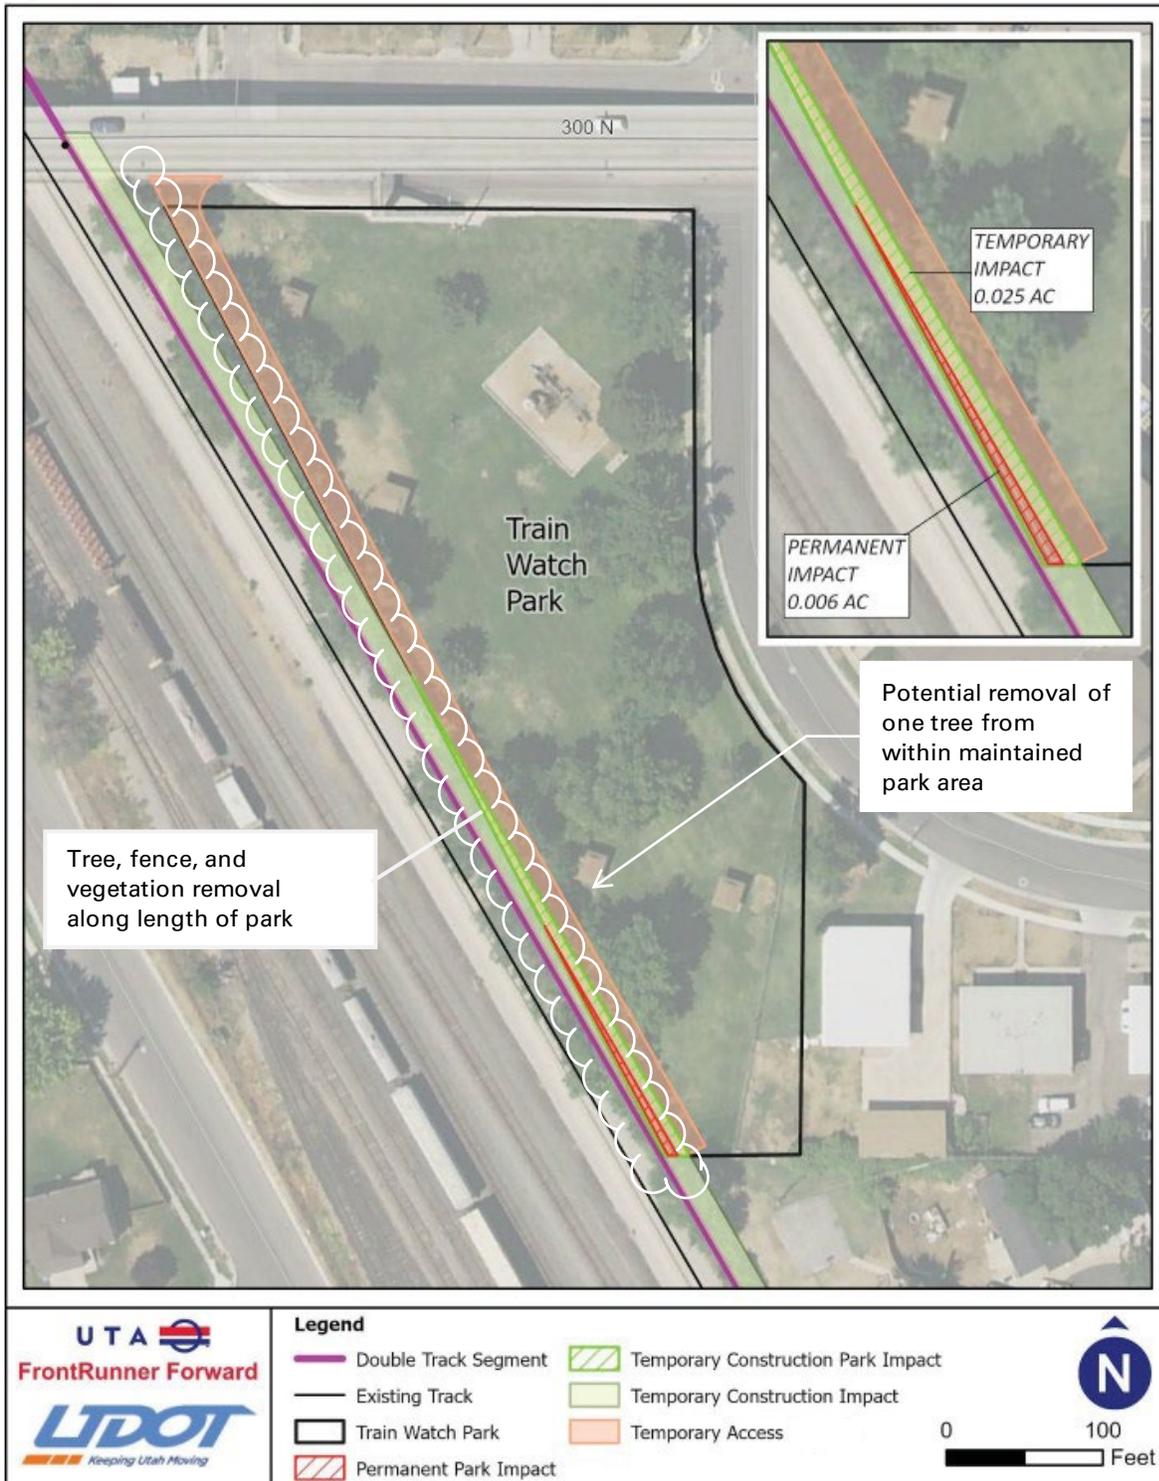
Figure 7. Train Watch Park Detail

The acquisition would not affect the active recreation (playground). Some of the picnic tables would be closer to the additional railroad tracks than they are today, but would not be directly affected. Removal of trees and shrubs within with UTA right-of-way, outside the park boundary, would provide a better view of the rail corridor and will enhance the train watching experience at Train Watch Park. UTA would coordinate with Clearfield to provide compensation for the acquired area and to replace and restore affected areas to the same condition or better than the area today. Temporary construction easements would be needed to construction the new fence, but it would not impact the active recreation (playground) or use of nearby areas in the park. The park would remain open to the public during construction.

- The City of Clearfield will be coordinated with regarding impacts to Train Watch Park including compensation for the acquired area and replacement and restoration of affected areas to the same condition or better than the current condition. Train Watch Park will remain open during construction. Refer to the project CE worksheet for additional details regarding mitigation.

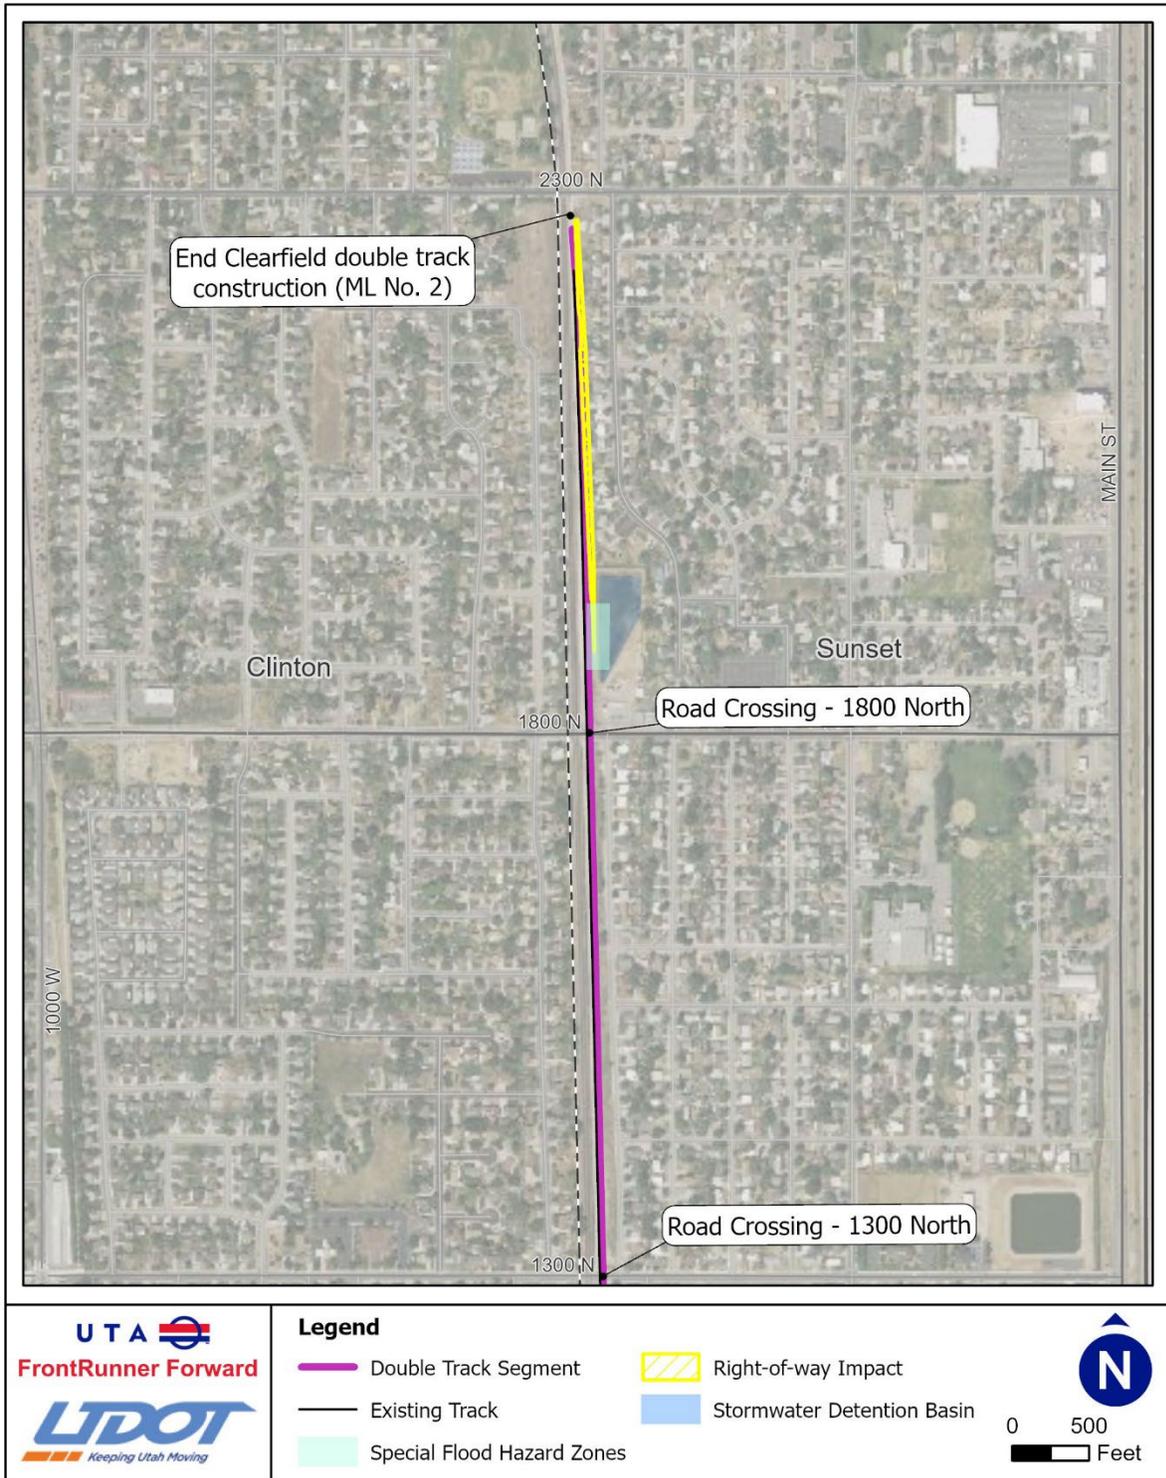
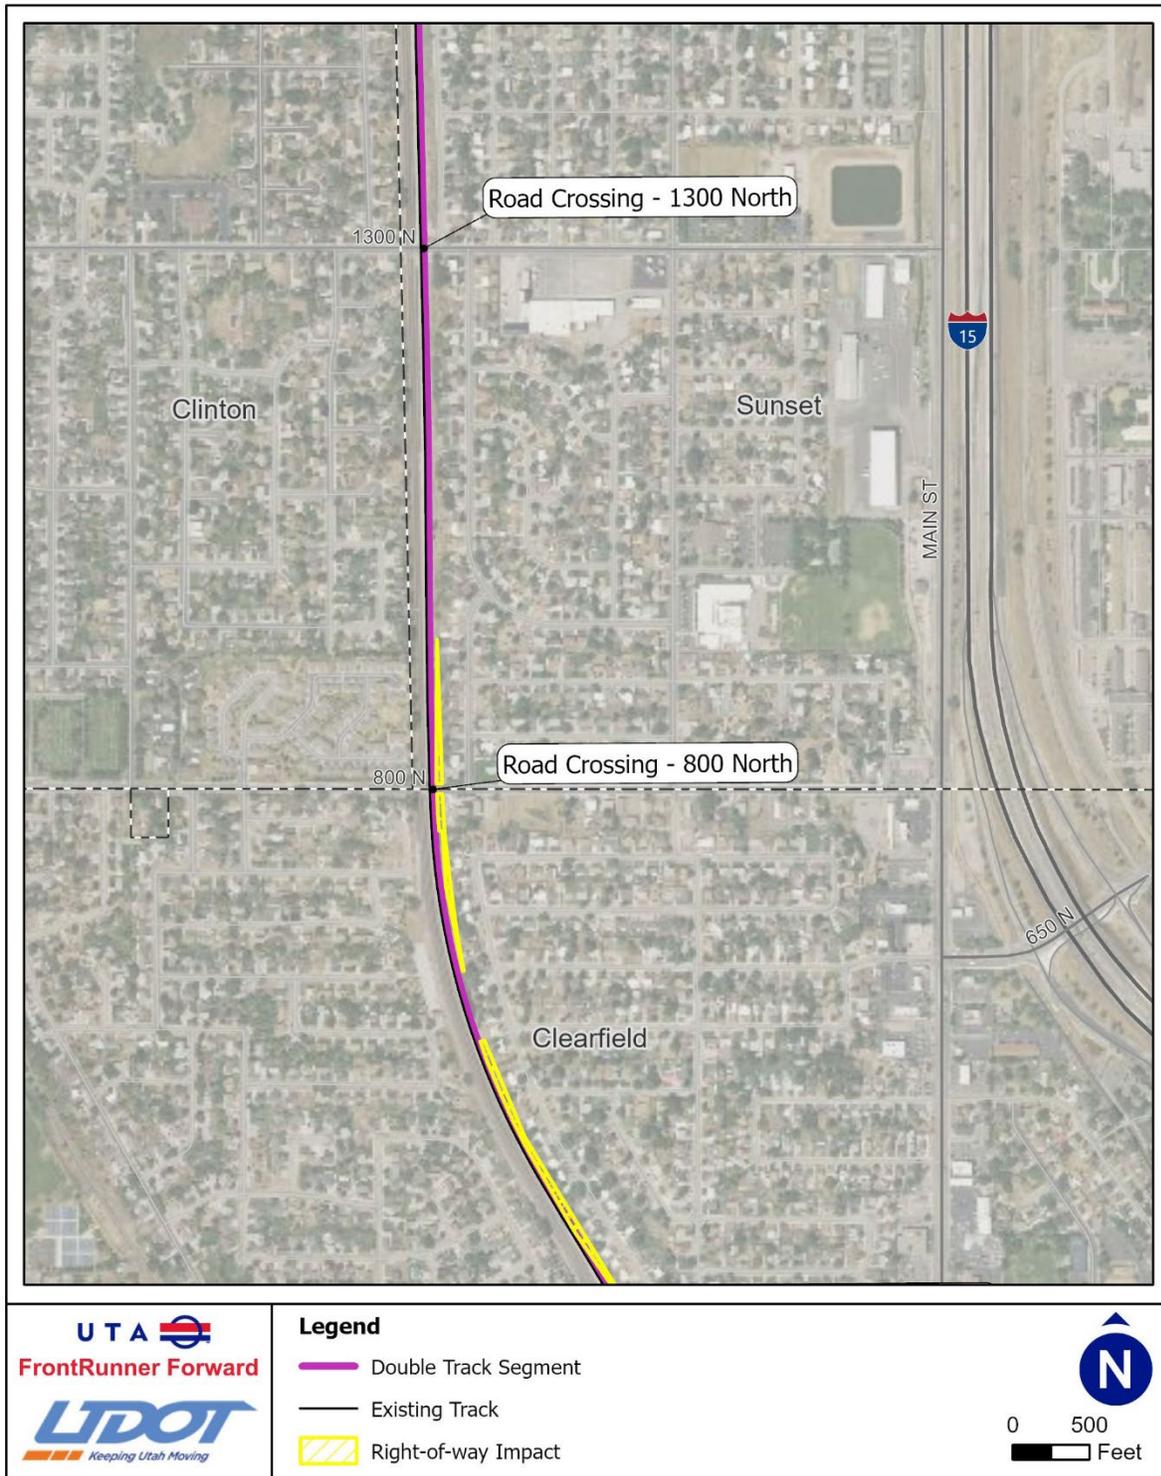
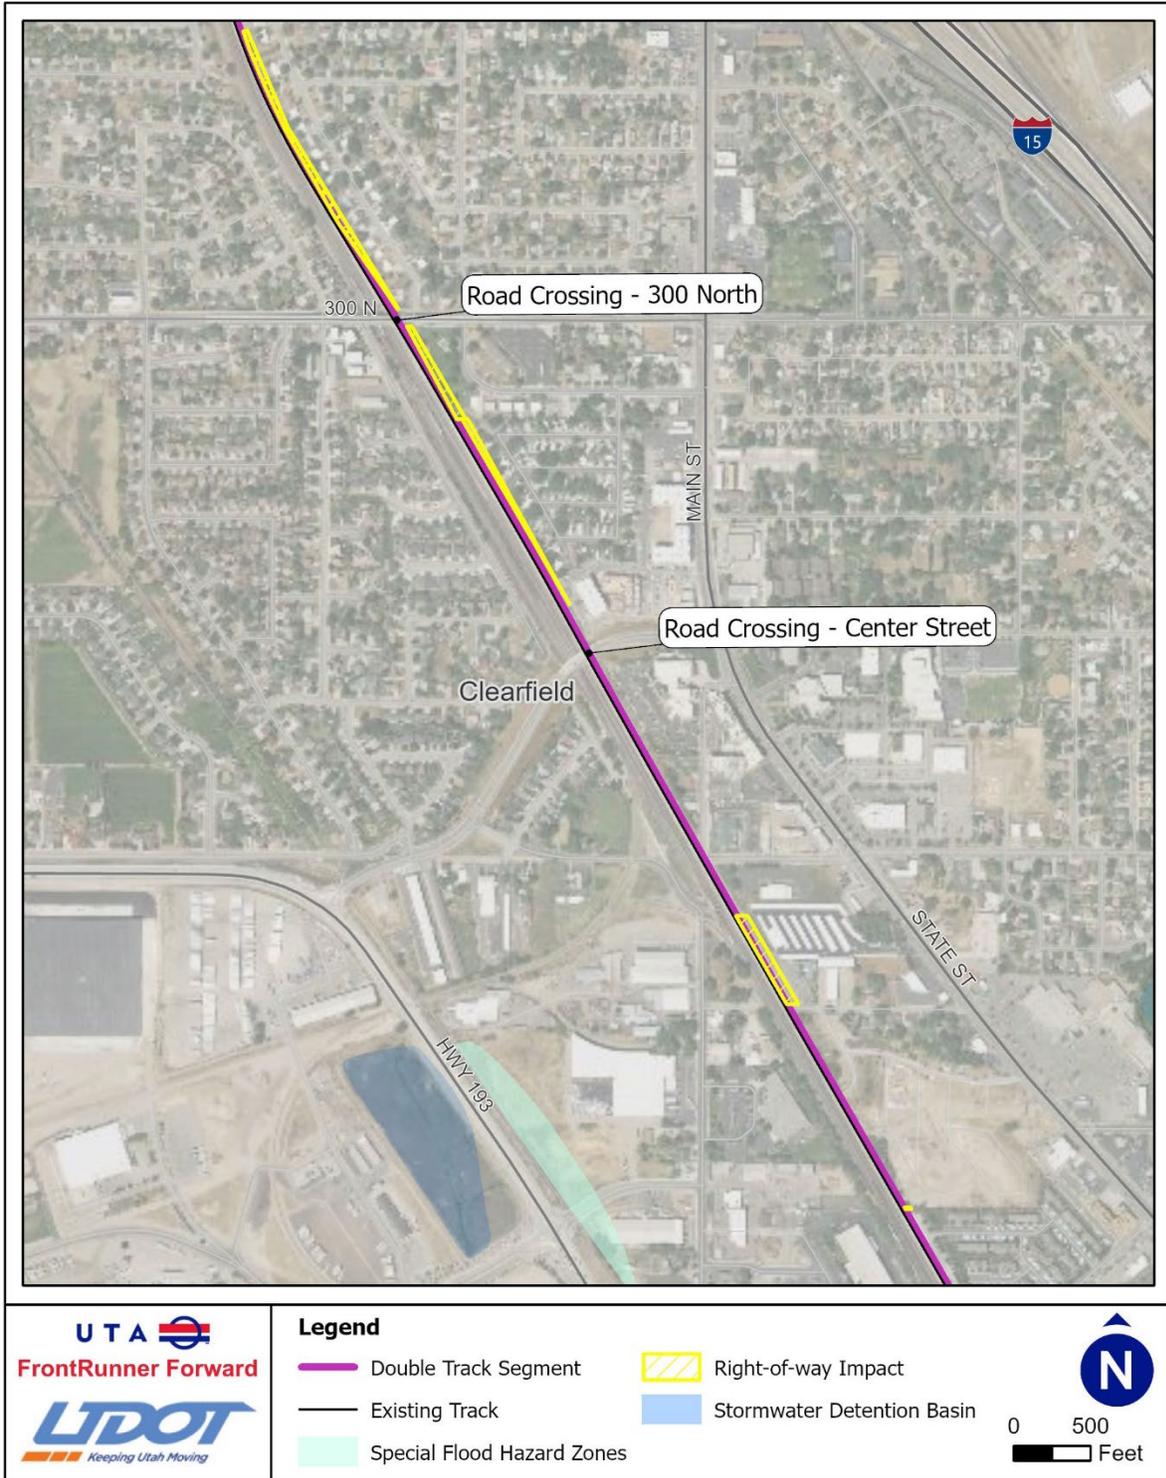
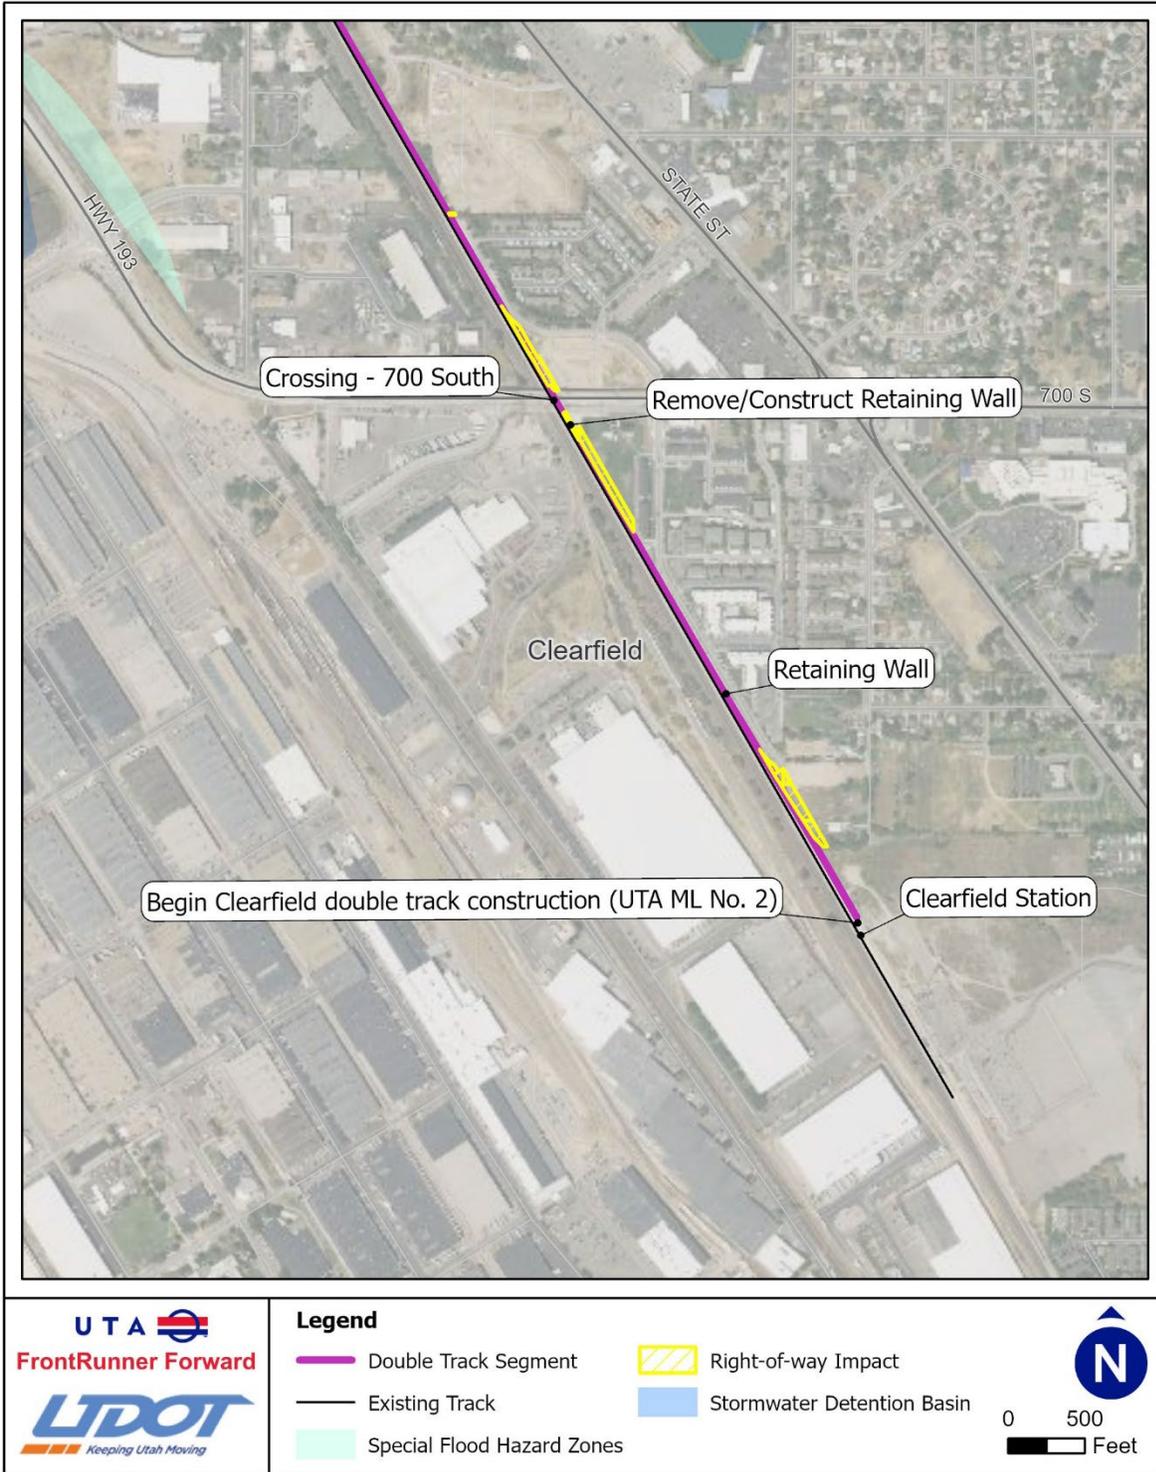
Figure 9. Floodplains, 1 of 4

A FEMA Special Flood Hazard Zone is within the project area, located between stations 44950+00 and 44945+00 (near 1800 North). See Figure 9 in Attachment 1.

The Project will add ballast within the flood hazard area to support the second set of tracks. The final design would include additional storage capacity or other modifications within the flood zone to minimize any increase in the base flood elevation. An evaluation would be completed to determine if the final design would require revision to the flood map. This would be coordinated with Sunset City, which is the floodplain administrator for this area. If necessary, a pre-construction Conditional Letter of Map Revision (CLOMR) would be submitted to FEMA. After construction a Letter of Map Revision (LOMR) would be submitted to FEMA. This process would be coordinated with Sunset City. In addition, a floodplain development permit would be obtained from Sunset City.

- An evaluation will be completed to determine if final design will require revision to the flood map. If necessary, a pre-construction Conditional Letter of Map Revision (CLOMR) will be submitted to FEMA. After construction a Letter of Map Revision (LOMR) will be submitted to FEMA, if required. Sunset City, the floodplain administrator for the area, will be coordinated with regarding this process. In addition, a floodplain development permit will be obtained from Sunset City.

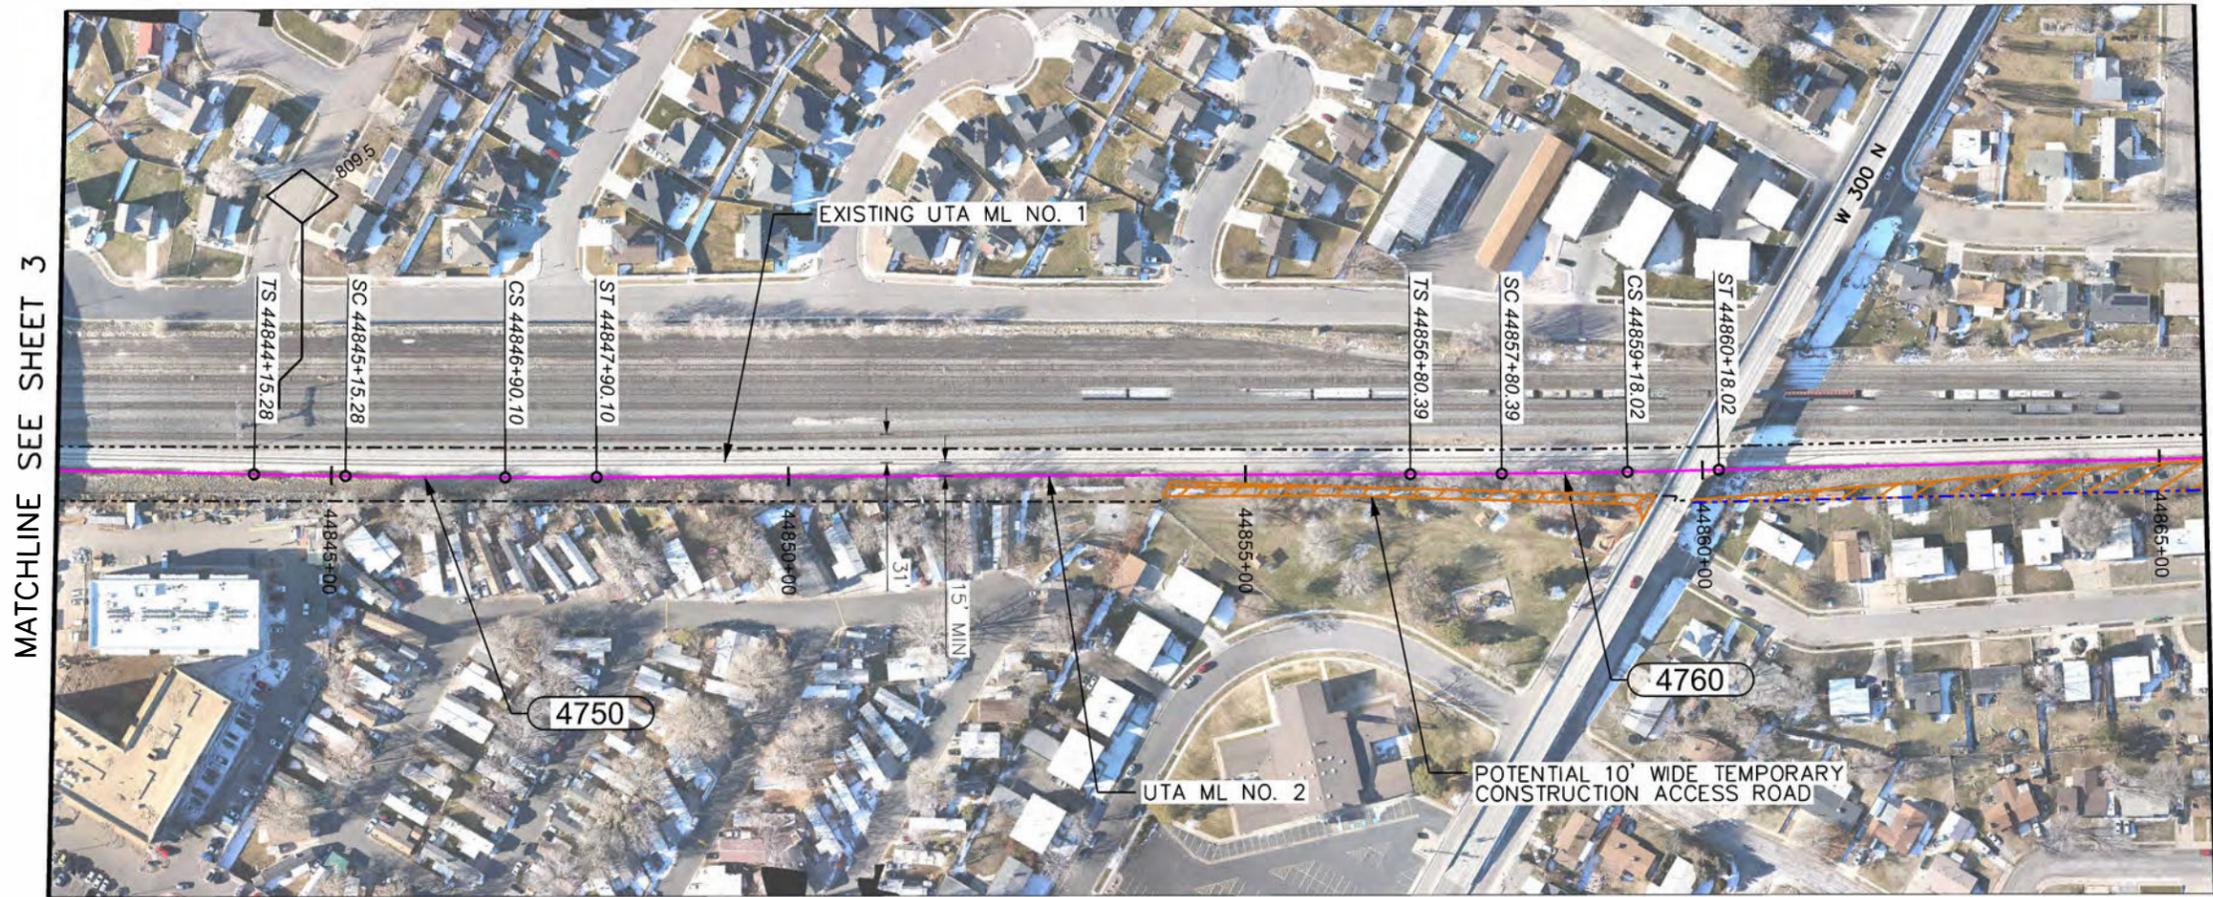
CURVE DATA							
CURVE ID	RADIUS	SPEED	E _o	E _u	L _s (ft)	D(Arc)	L (ft)
4750	11,475.00	79	1.50	0.68	100	0°29'58"	174.826
4760	11,475.00	79	1.50	0.68	100	0°29'58"	137.635

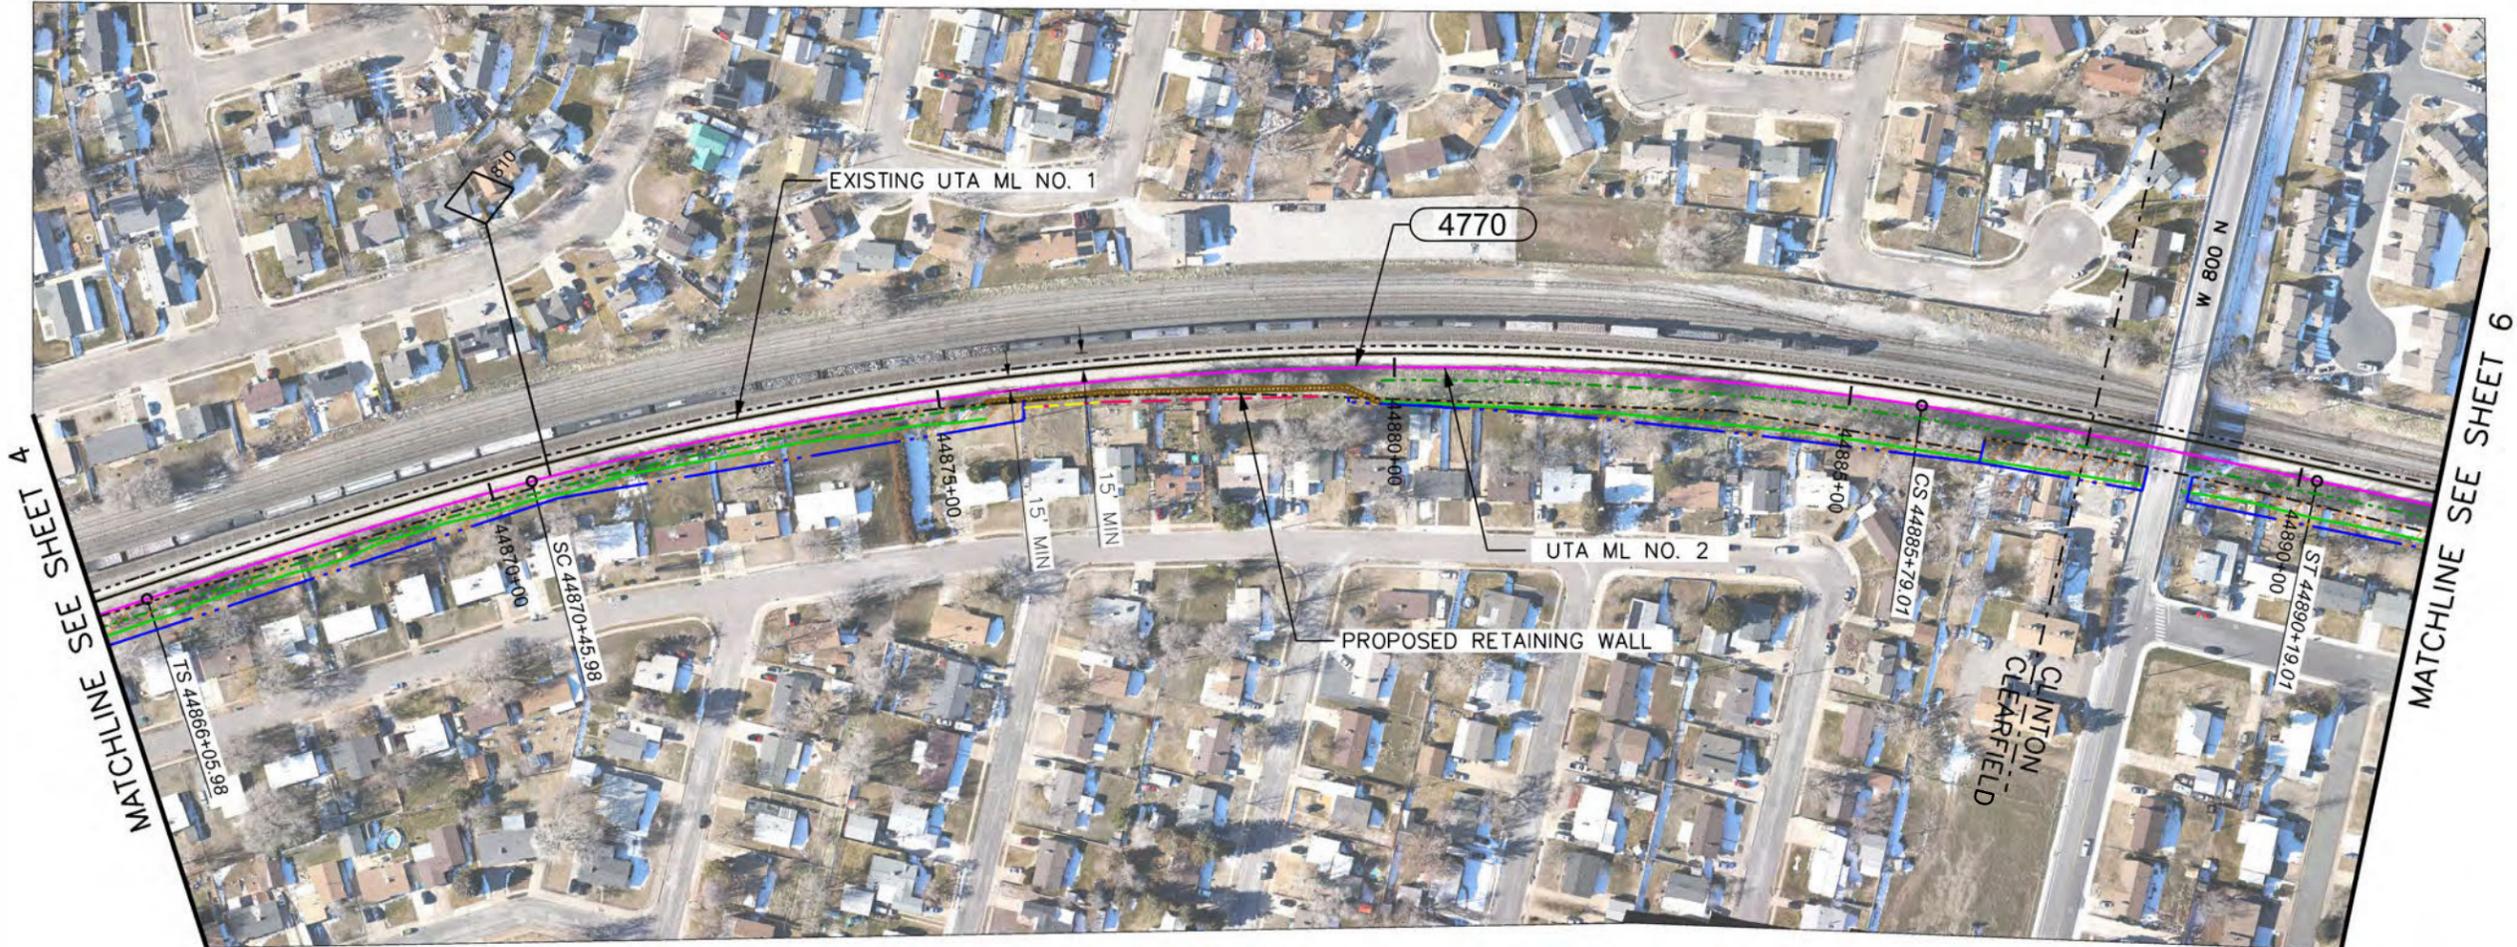
CURVE DATA							
CURVE ID	RADIUS	SPEED	Eo	Eu	Ls (ft)	D(Arc)	L (ft)
4770	3,770.00	79	4.50	2.14	440	1°31'11"	1,533.033

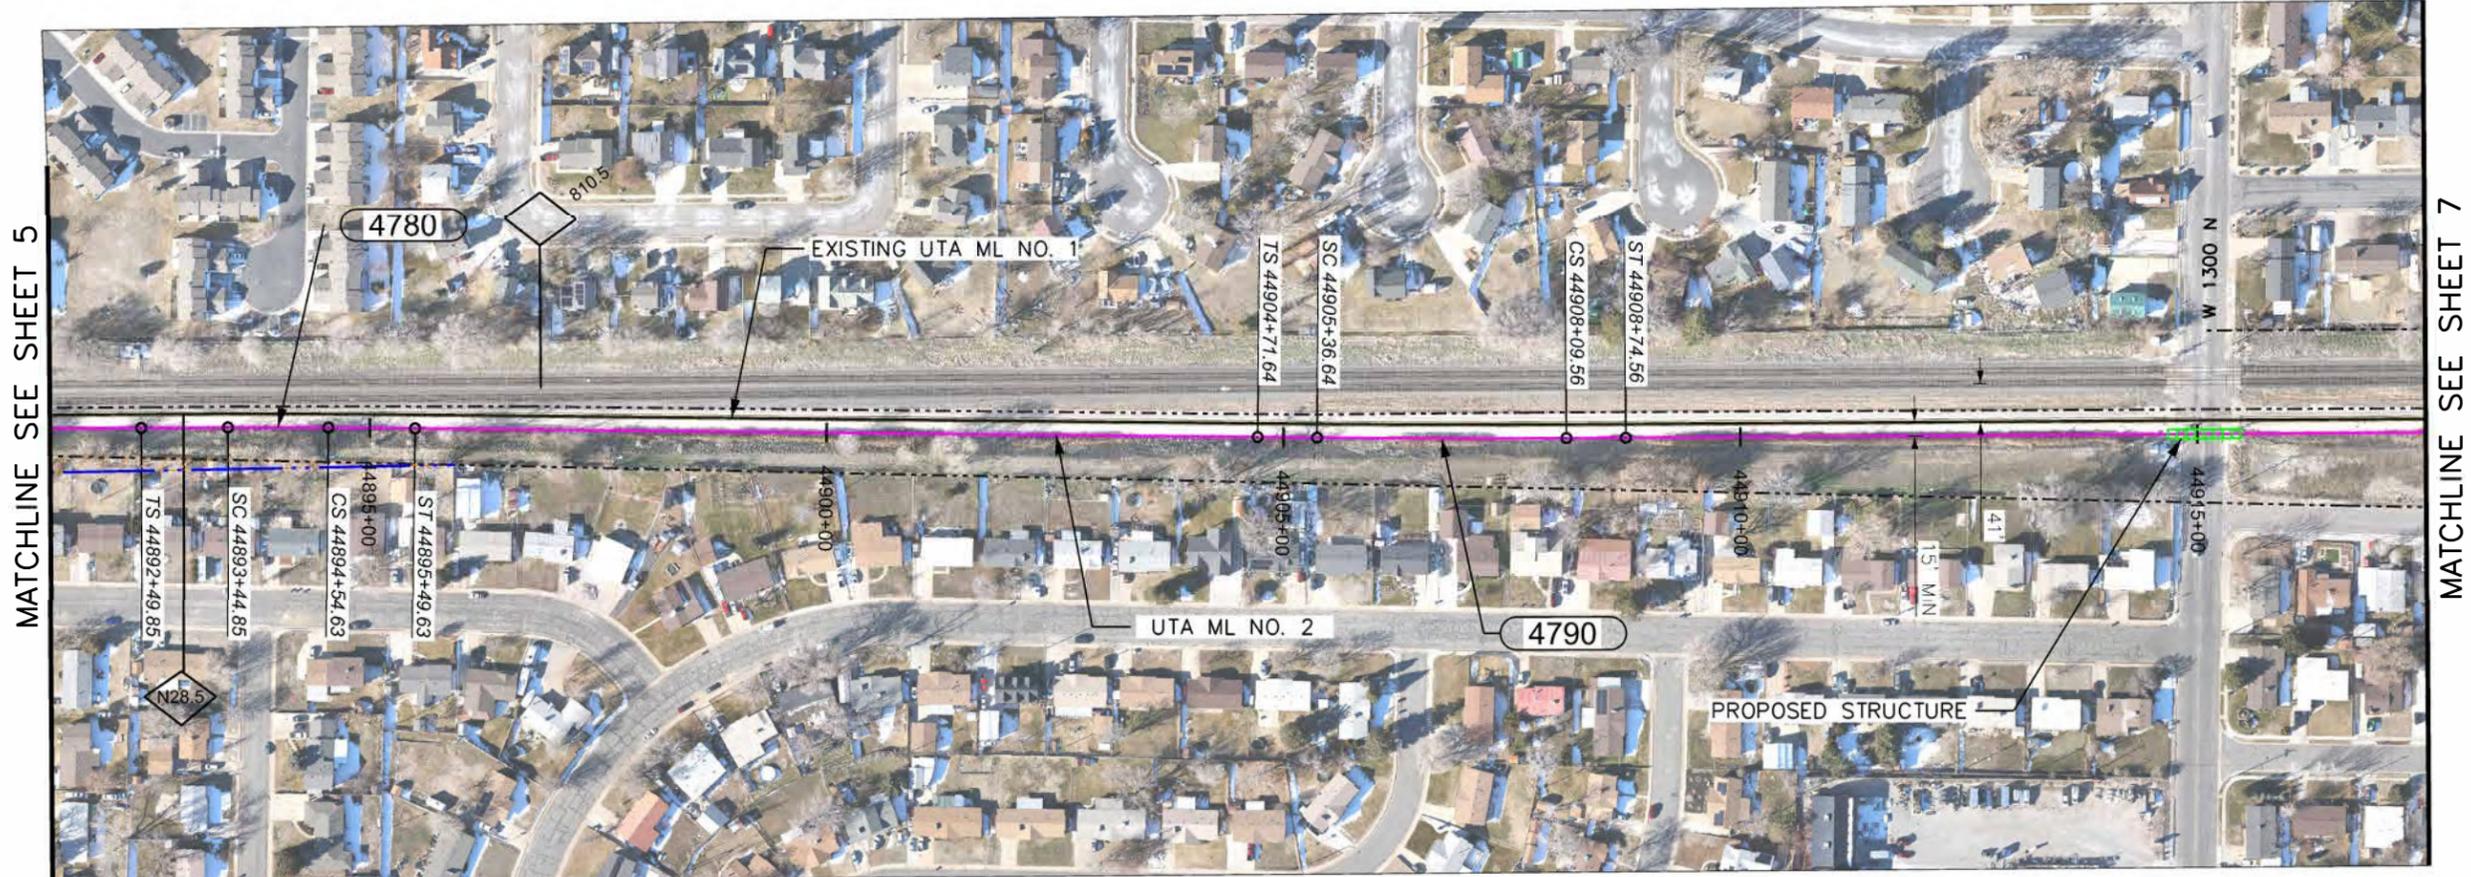
CURVE DATA							
CURVE ID	RADIUS	SPEED	Eo	Eu	Ls (ft)	D(Arc)	L (ft)
4780	11,460.00	79	1.50	0.68	95	0°29'60"	109.780
4790	20,000.00	79	1.00	0.25	65	1°17'11"	272.918

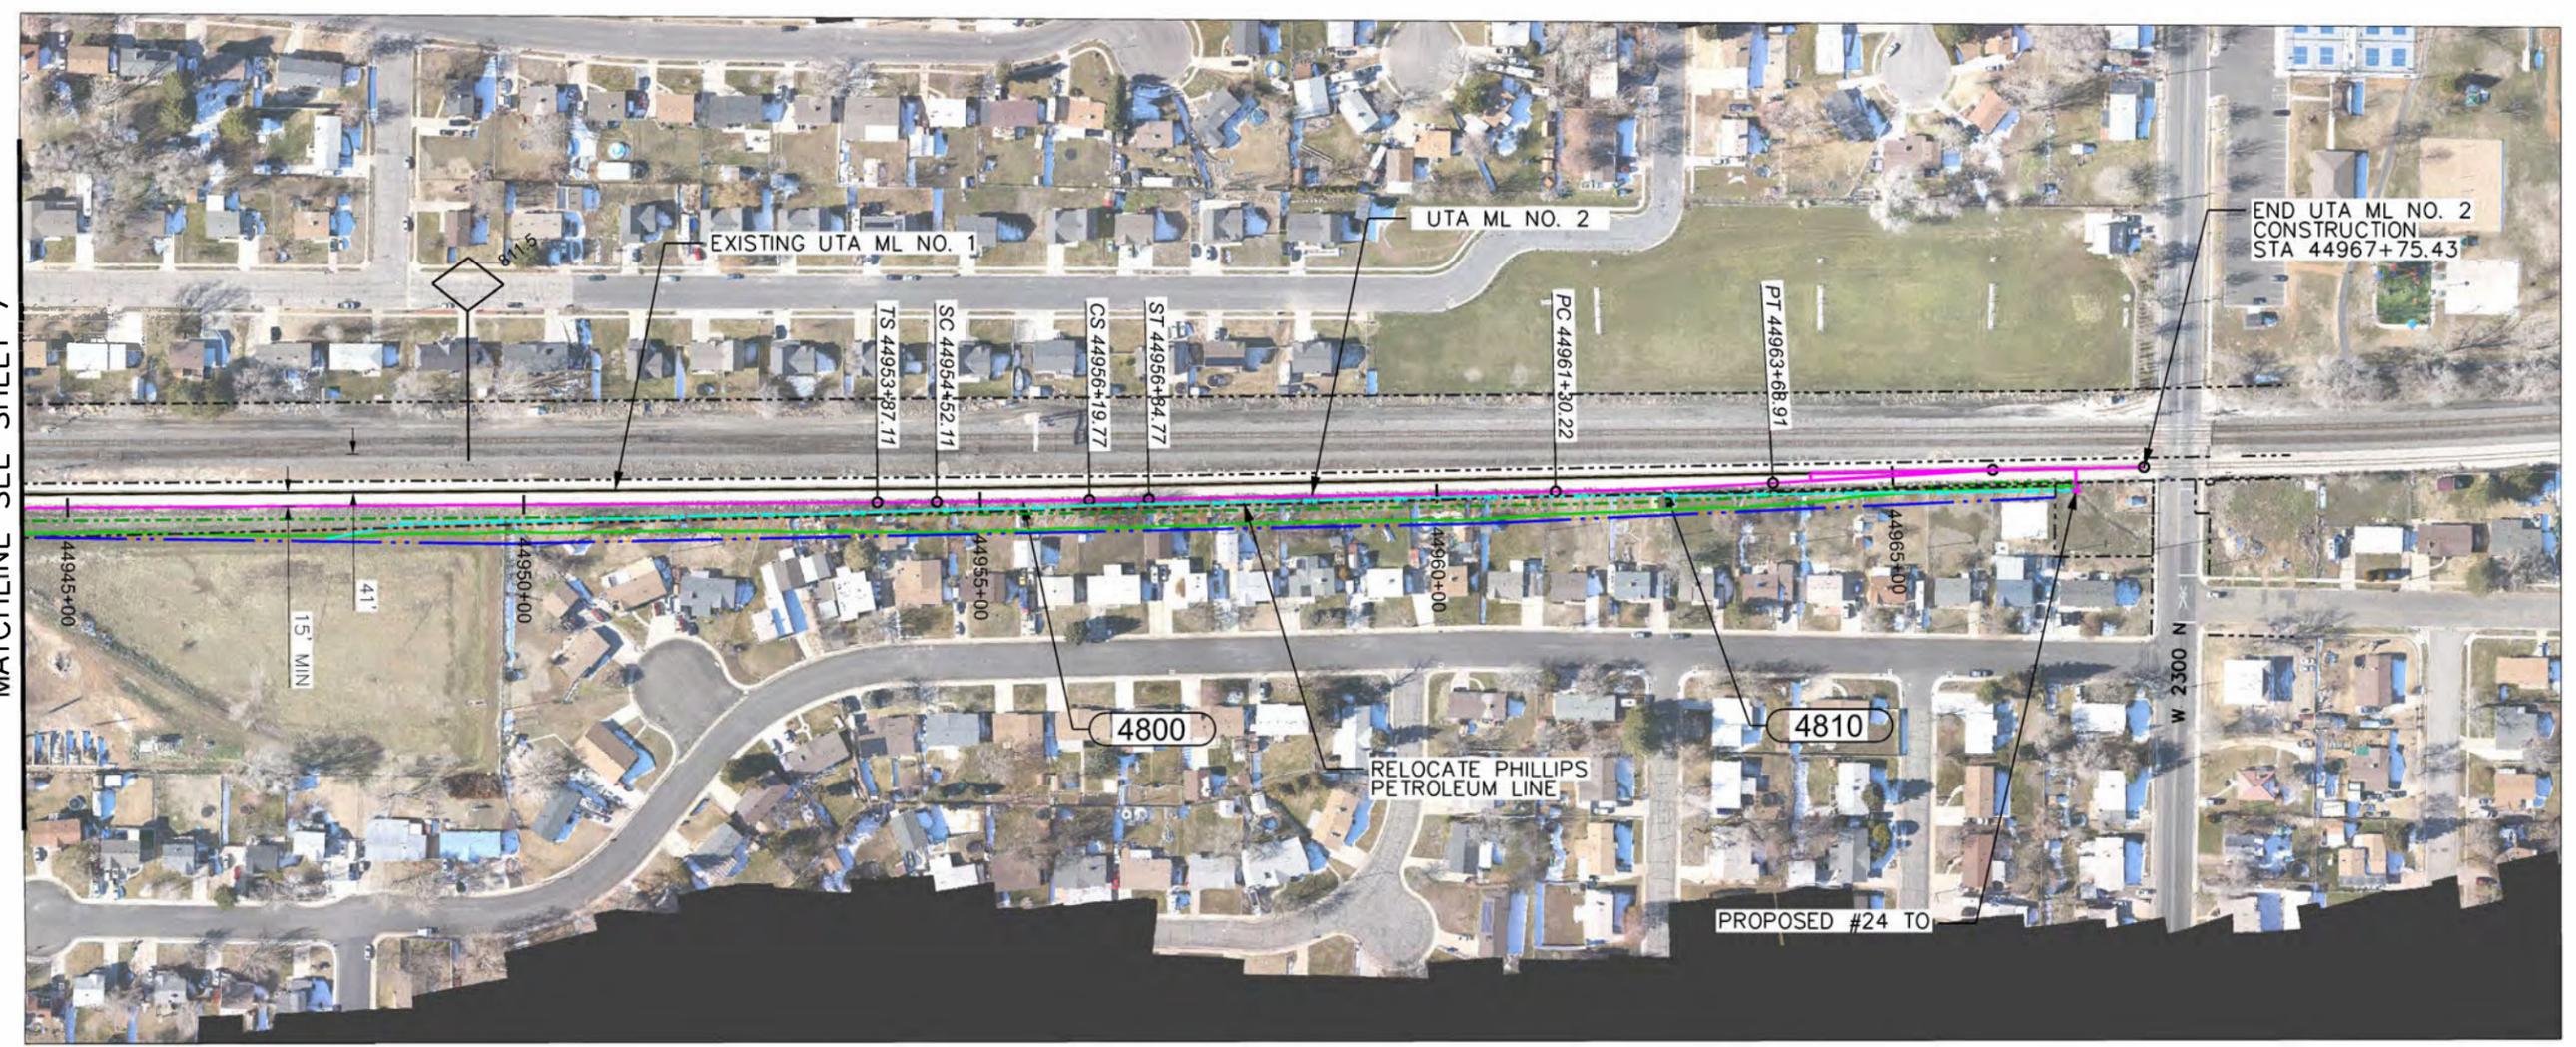
CURVE DATA							
CURVE ID	RADIUS	SPEED	Eo	Eu	Ls (ft)	D(Arc)	L (ft)
4800	20,000.00	79	1.00	0.25	65	0°17'11"	167.658
4810	5,729.58	45	0.00	1.42		1°0'0"	238.694

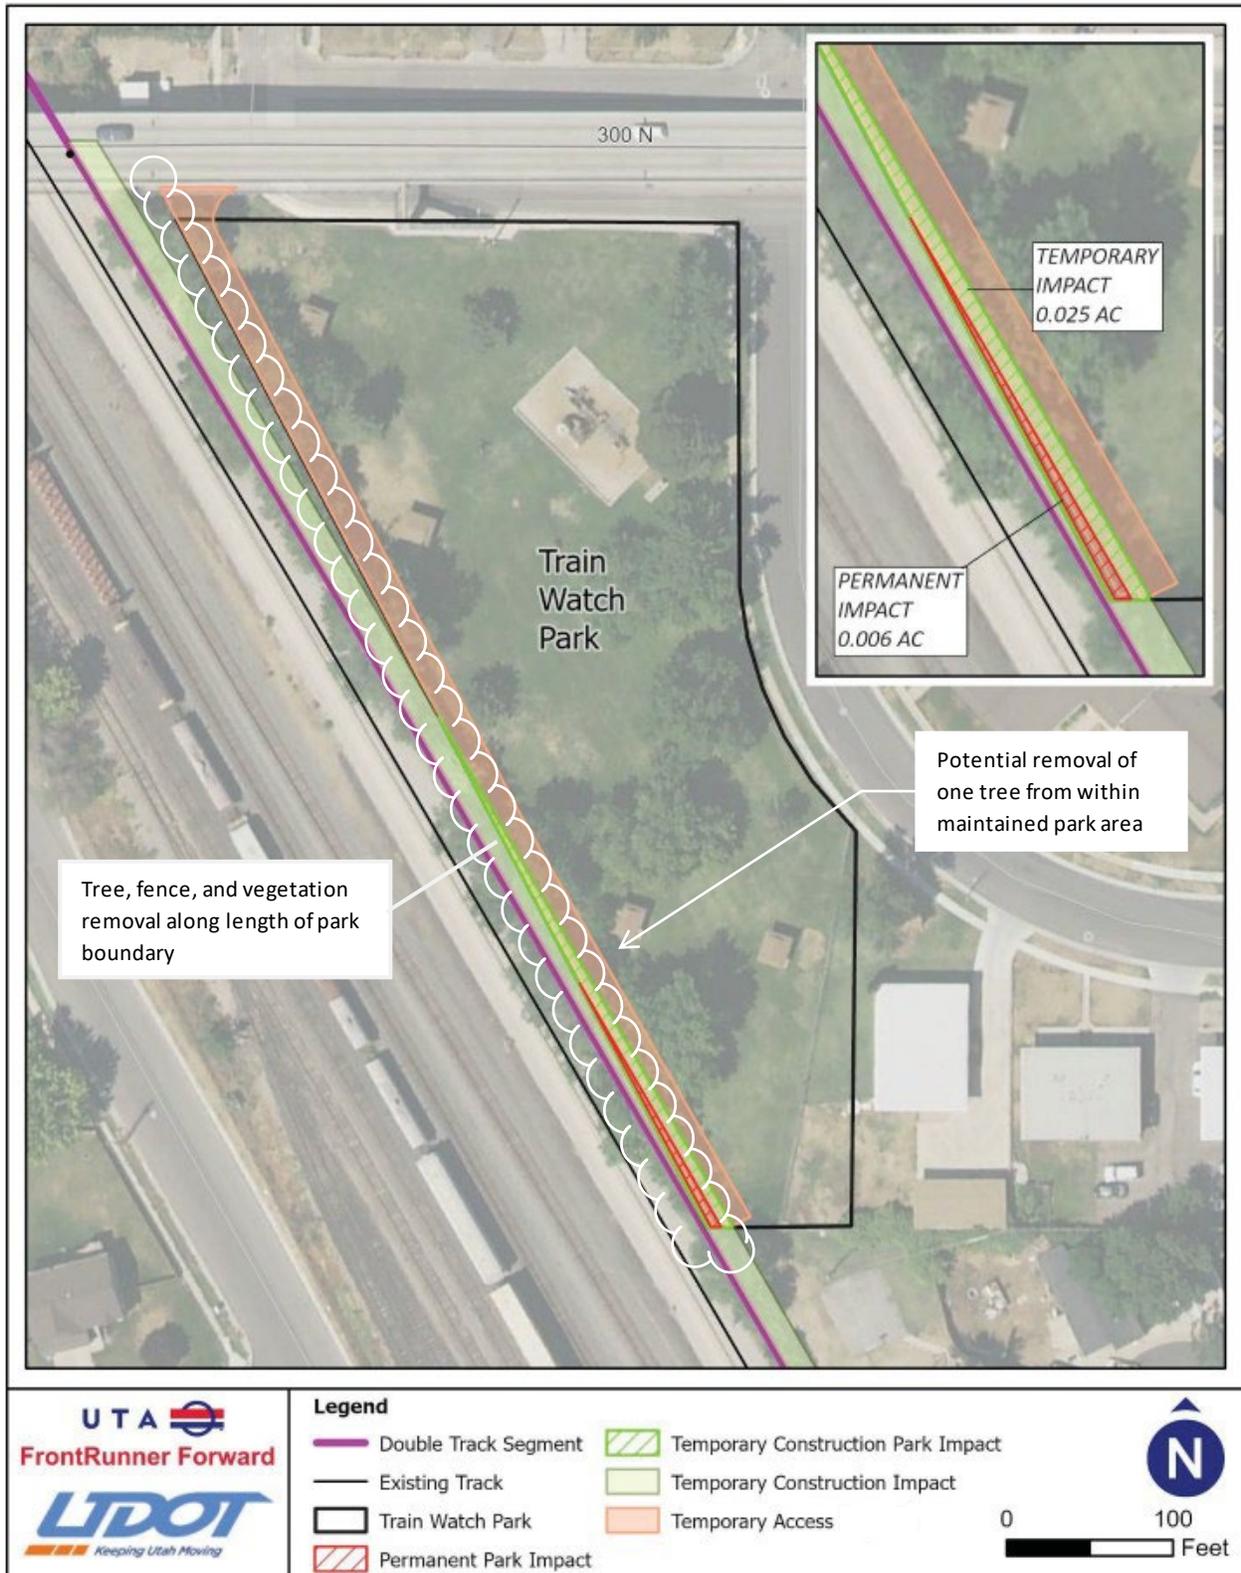
Figure 3. Train Watch Park Temporary and Permanent Impacts

UTA would provide Clearfield City just compensation for the acquisition of park property and mitigate construction impacts by replacing the fence and restoring park landscaping to the same conditions or better than existing. The Project team would consult with Clearfield City on the design of the replacement fencing and landscaping, including for the replacement of any trees that had been removed from within the maintained park area.

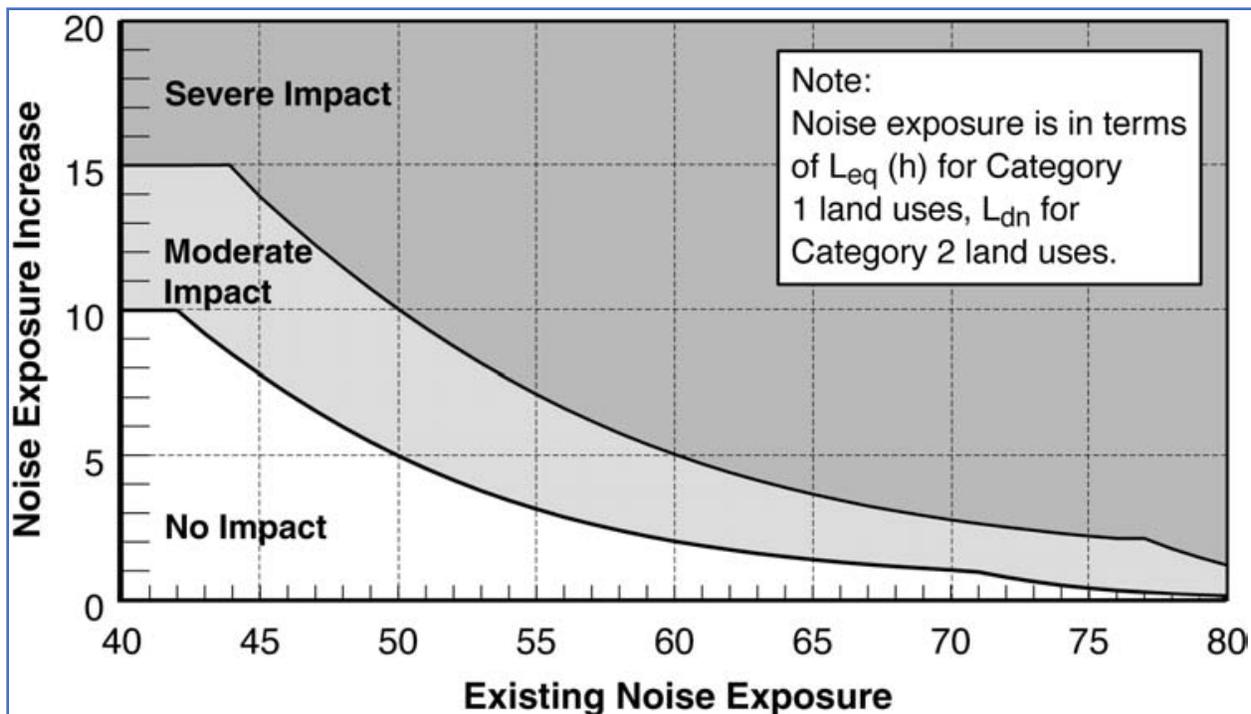
Figure 1. FTA Cumulative Noise Impact Criteria

- **No Impact:** In this range, the project is considered to have no impact since, on average, the introduction of the project will result in an insignificant increase in the number of people highly annoyed by the new project noise.
- **Moderate Impact:** Project-generated noise in this range is considered to cause impact at the threshold of measurable annoyance. Moderate impacts serve as an alert to project planners for potential adverse impacts and complaints from the community. Mitigation should be considered at this level of impact based on project specifics and details concerning the affected properties.
- **Severe Impact:** Project-generated noise in this range is likely to cause a high level of community annoyance. Noise mitigation should be applied for severe impacts where feasible.
