Re: NEPA Approval for the **FrontRunner Forward Program – North of Clearfield Double Track Project**

**Attachment 1:
North of Clearfield Double Track Project
Figures**

**Attachment 2:
North of Clearfield Double Track Project
Plan Set**

**Attachment 5:
North of Clearfield Double Track Project
Noise and Vibration Assessment**

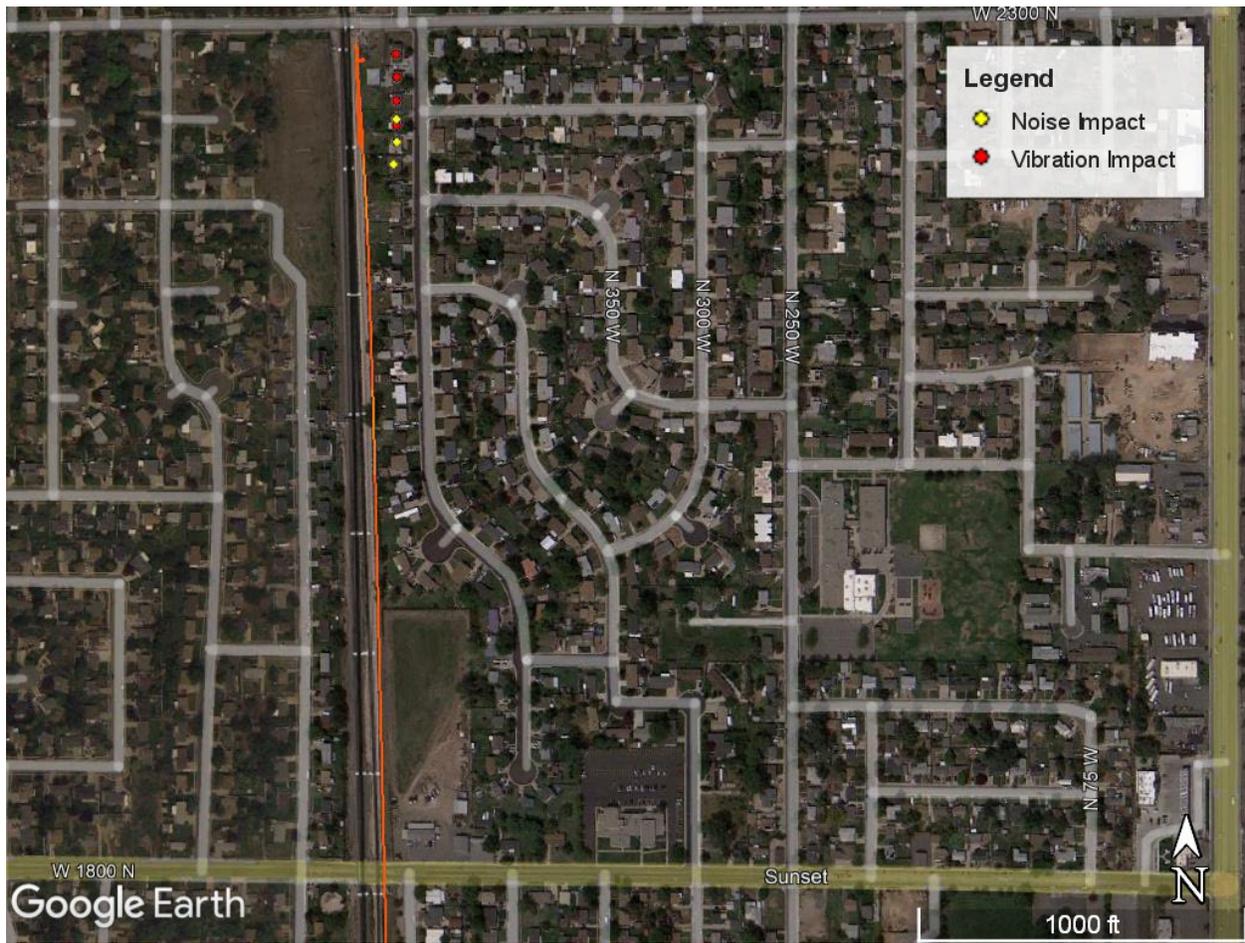
Figure 2. Clearfield Segment Noise and Vibration Impact Locations

A spring-rail frog is a special type of turnout that closes the gap in the tracks in the main direction of travel but would still have a gap for the diverging movement onto or off of the second track. Because the spring-rail frog would eliminate the gap in the tracks in the main direction, the noise levels would be sufficiently reduced to avoid impacts. A ballast mat is a flexible and durable material (such as a high-resin rubberized material) that is installed directly under the track ballast to isolate vibrations as the train rolls over the tracks. The ballast mat would sufficiently dampen the vibration from the turnout to avoid any potential vibration impacts.

- Noise impacts will be mitigated by utilizing a spring-rail frog which closes the gap in the tracks in the through direction. Approximately 300 feet of ballast mat will be utilized beneath the turnout.

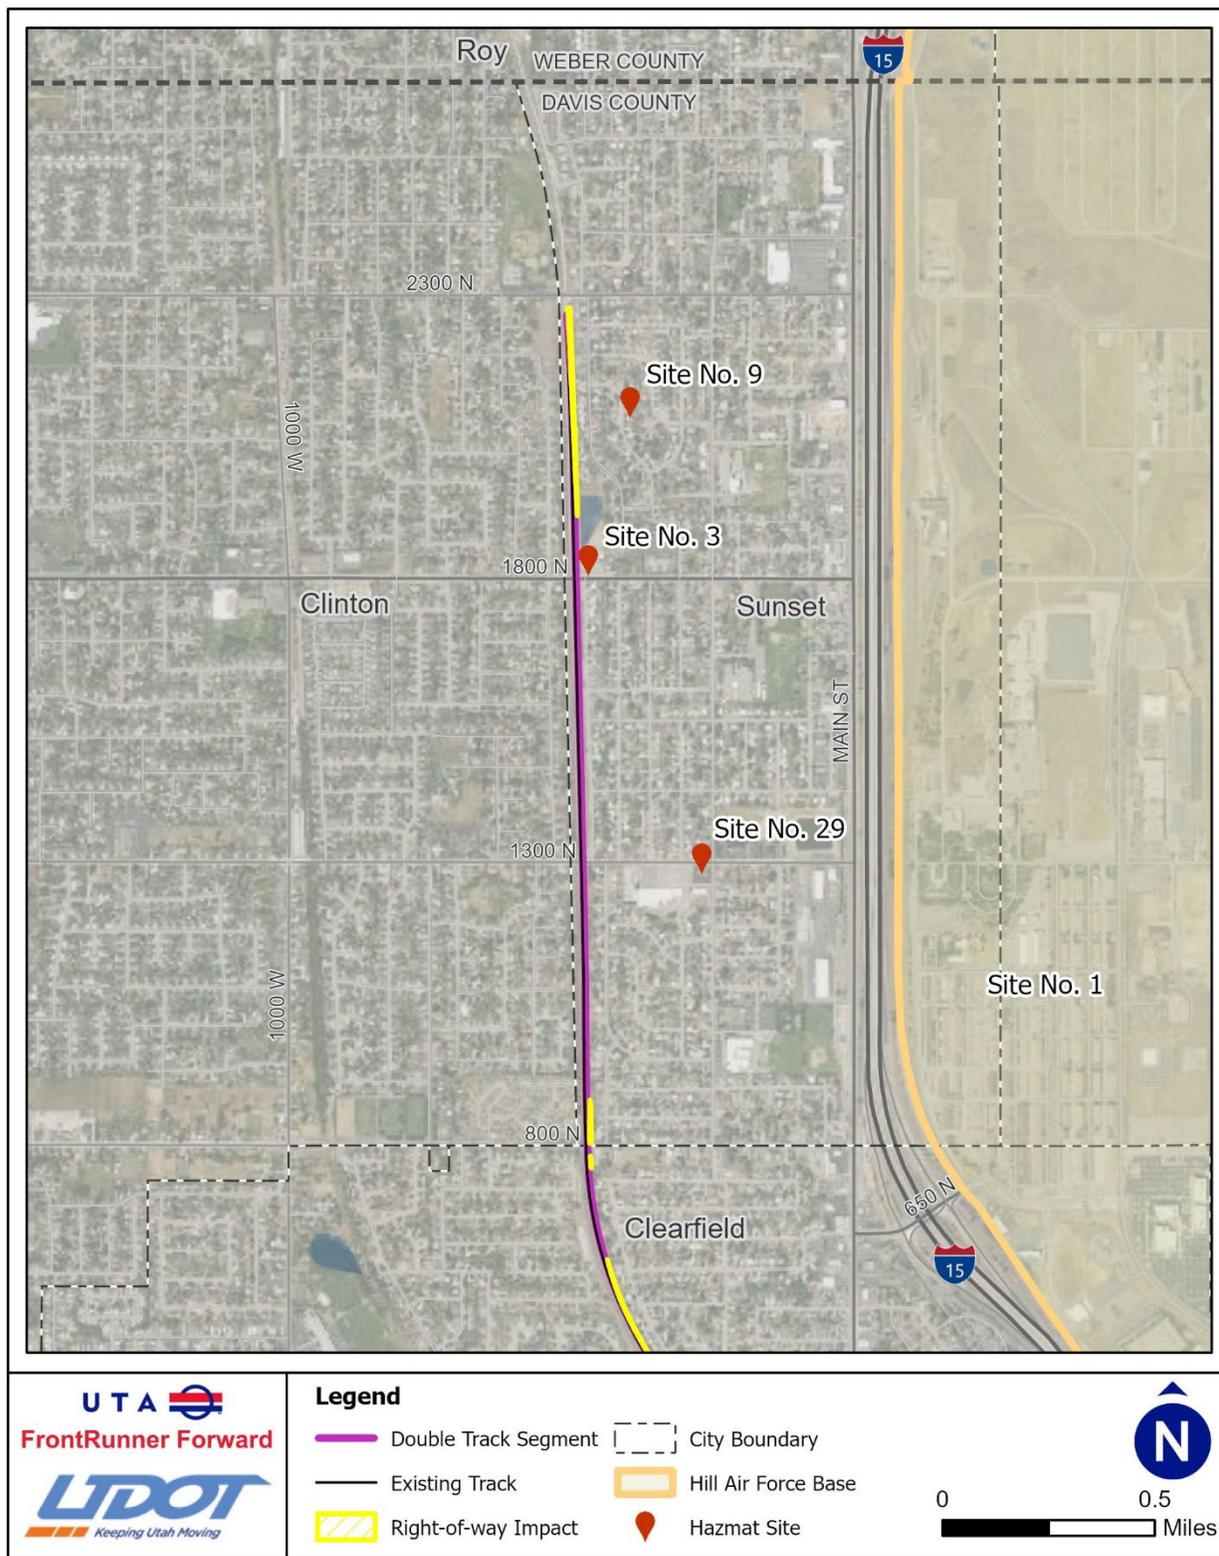
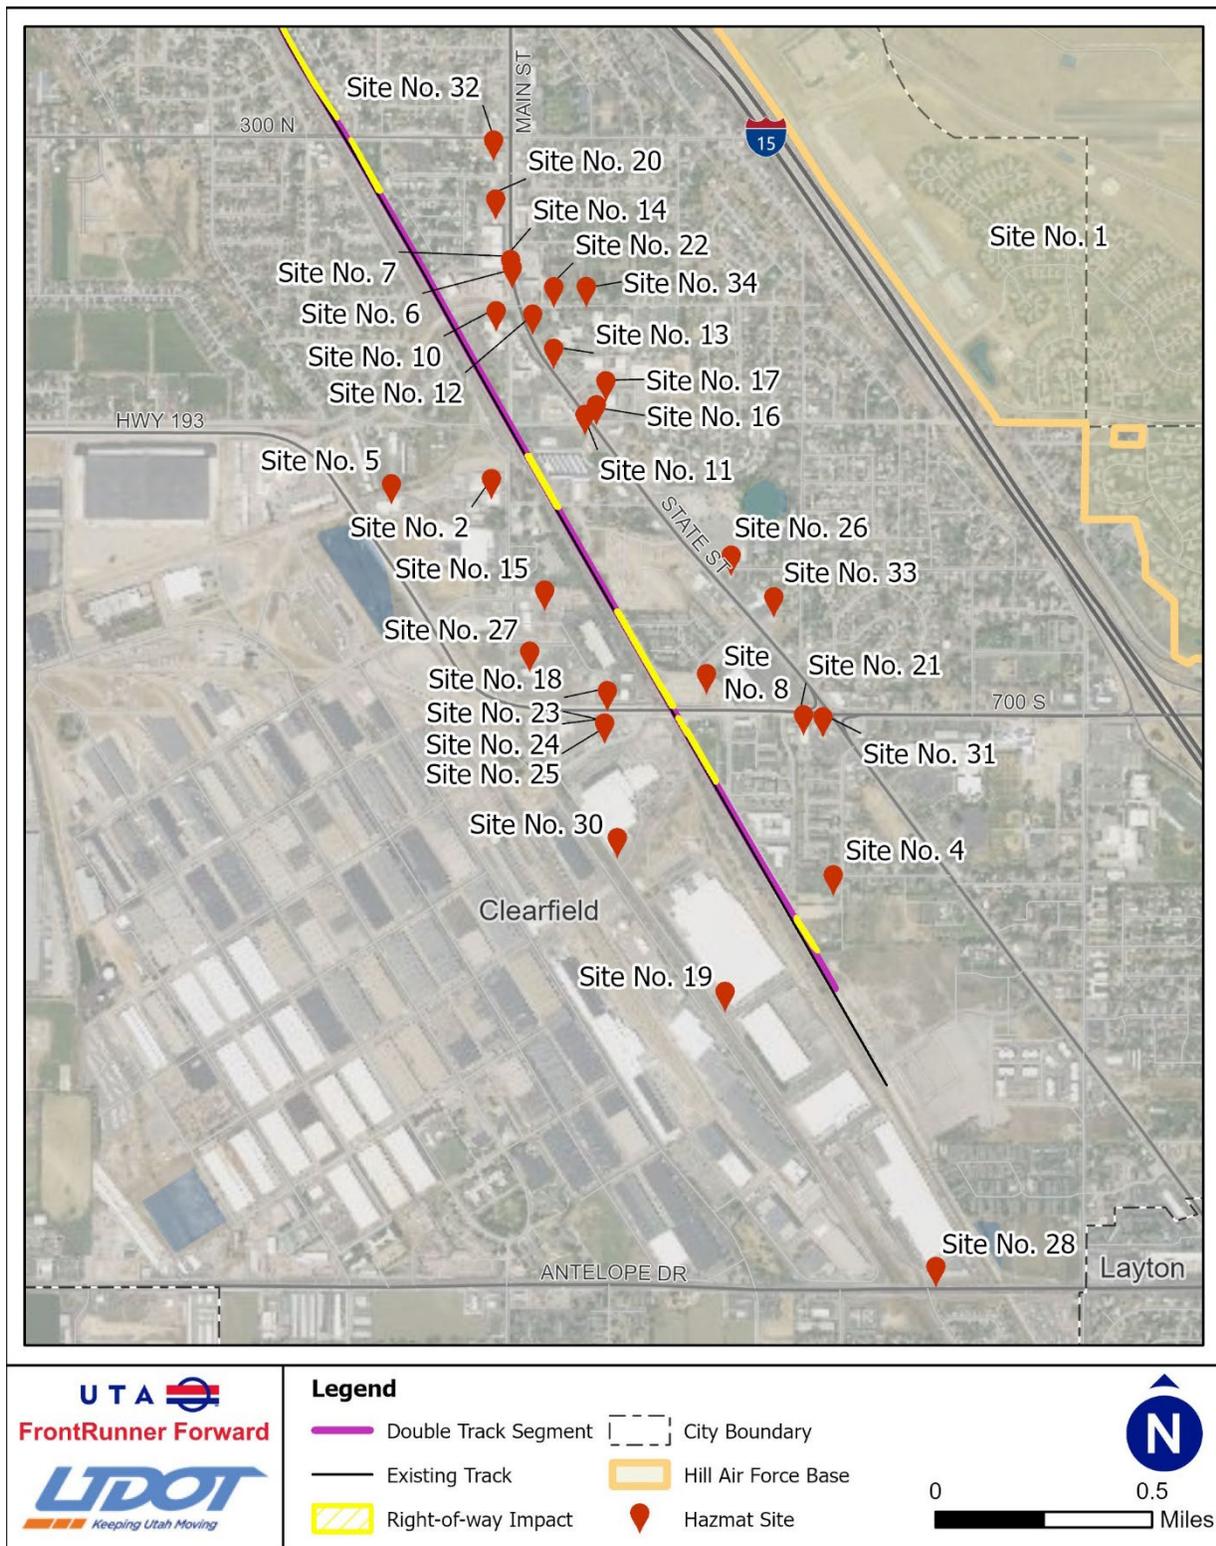
Figure 2. Map of Evaluated Sites, 1 of 2

State databases list several sites that indicate a confirmed release of a hazardous material or petroleum hydrocarbons within 0.25-mile of the Project area. One site associated with federal databases indicating a confirmed release was found within 1 mile of the Project area. A list of sites evaluated within 0.25 mile of the Project area can be found in Table 1, and they are shown in Figure 2 below.

A Hazardous Materials Assessment (Attachment 6) was completed using pertinent state and federal regulatory database information procured from Environmental Data Resources, Inc. (EDR) and publicly available sources to identify contaminated sites within 0.25 mile of the project area that have the potential to impact the project. Most sites identified in the project vicinity were not determined to have potential to impact the proposed project. Additionally, the sites are not expected to result in additional impacts to the environment as a result of the project. All sites within the 0.25-mile study area are shown in Figure 2, Attachment 6.

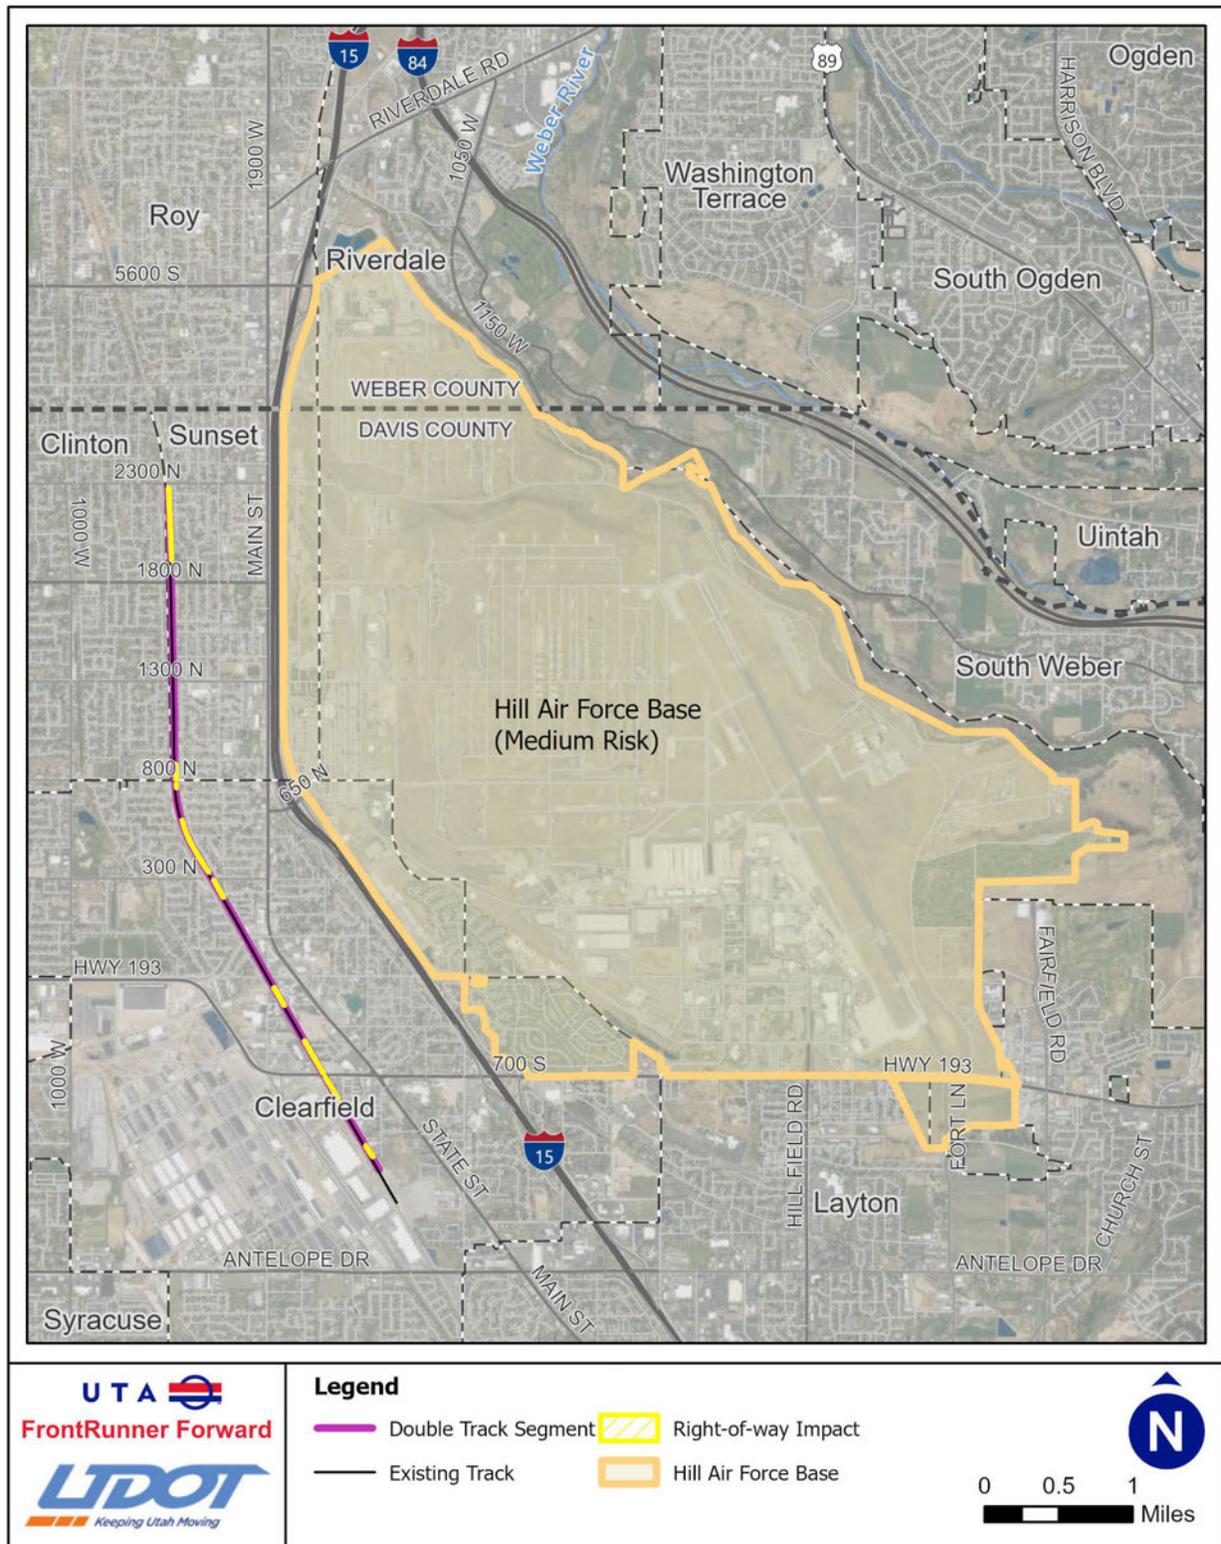
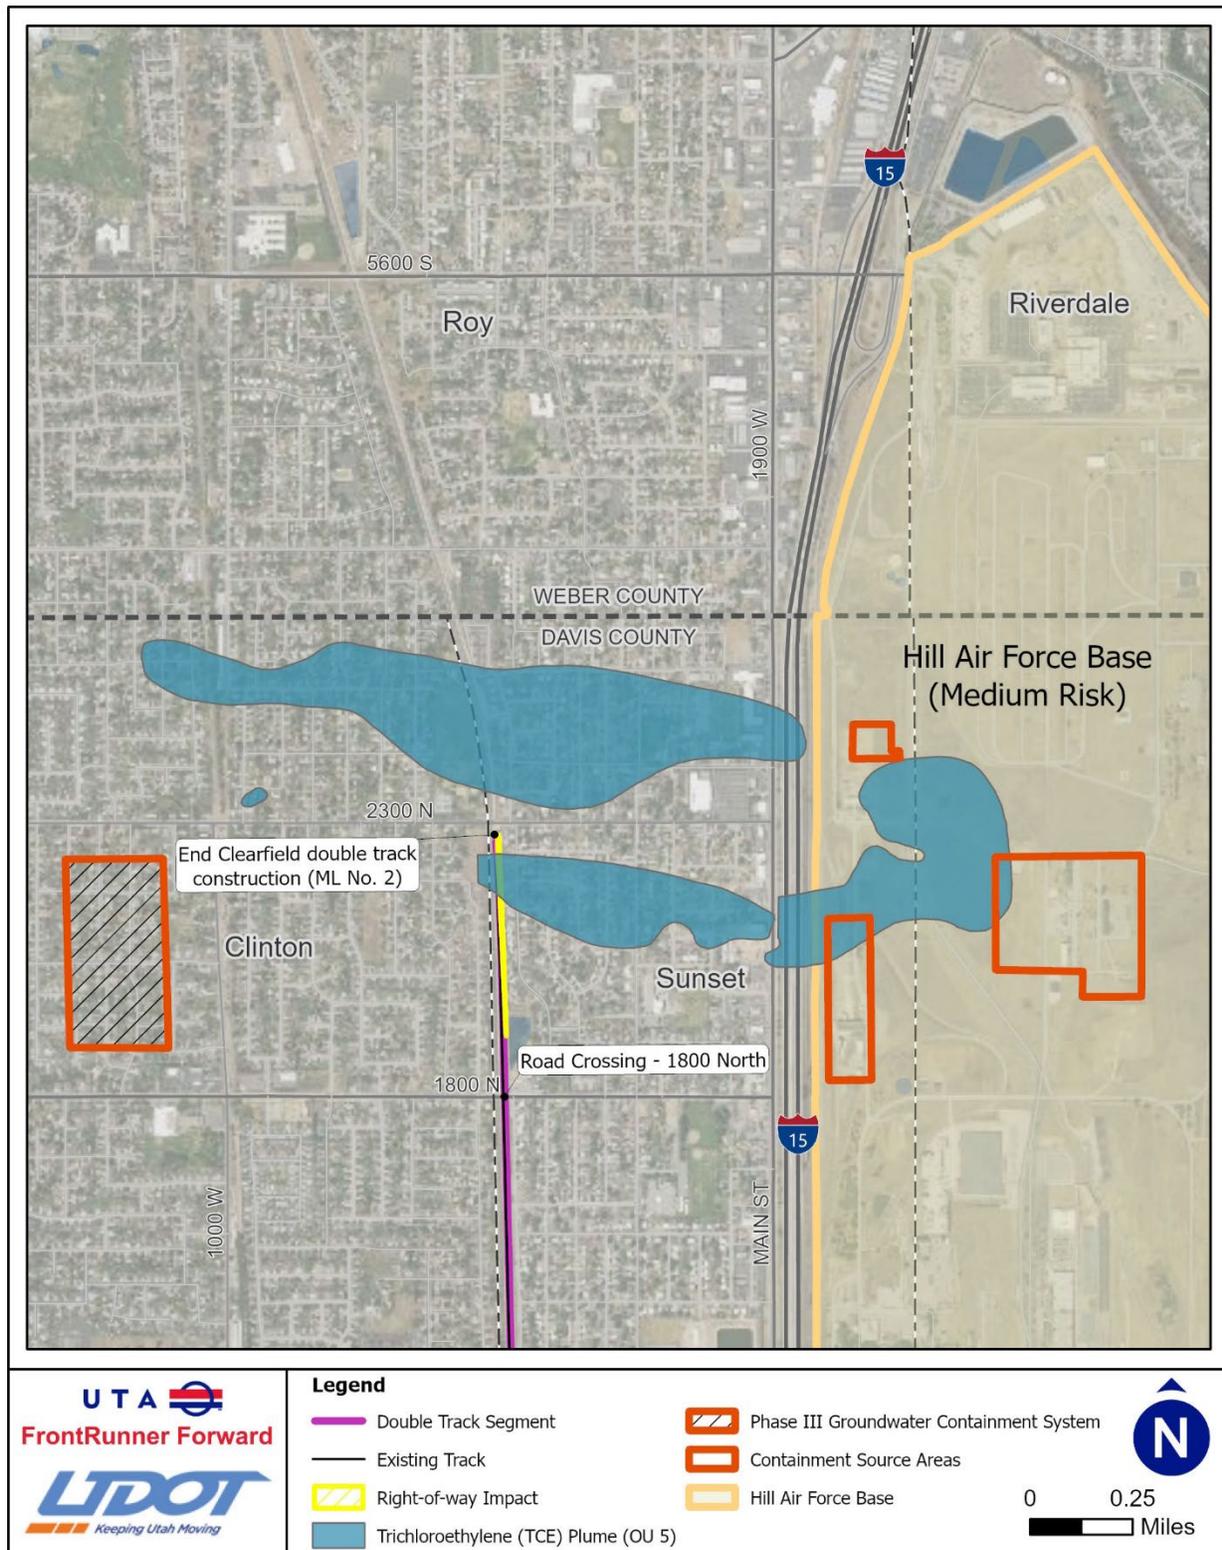
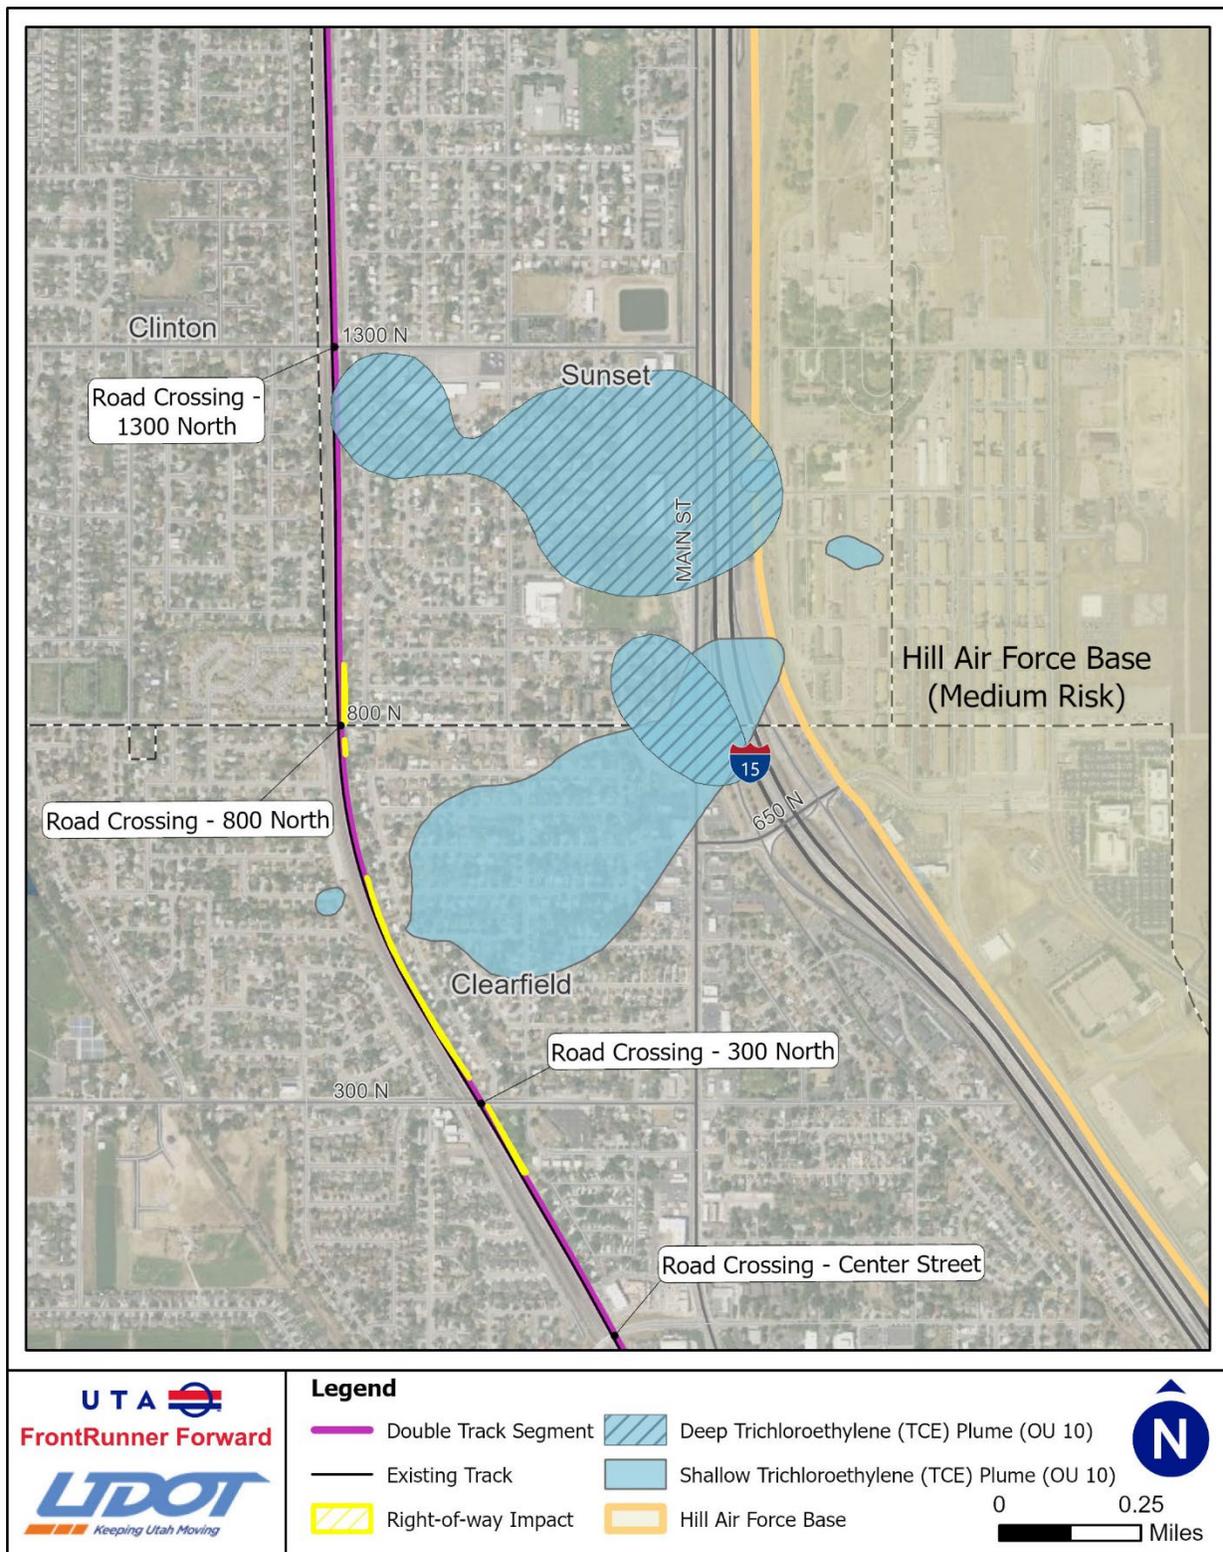
Figure 3. Hazardous Materials Site Detail, 1 of 3

Medium Risk

Hill Air Force Base – Operable Unit 5

groundwater contamination in the area of the delineated plume where it crosses the Project alignment, the site is classified as medium risk in this hazardous materials assessment.
